Chapel Hill East Condominium
Documents Relating to Construction Issues

Current 06/07/2023

CONDITION ASSESSMENT REPORT

Building Enclosure Science, LLC (BES) was commissioned by Acropolis Management Services (Acropolis) to perform a condition assessment of the building envelope at 7 Mount Hope Avenue, Providence, RI.

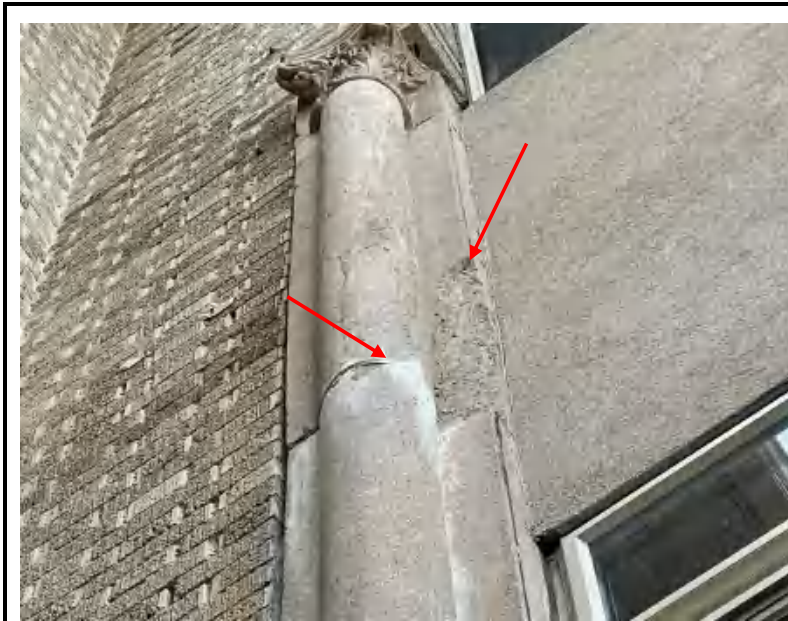
Figure 8

Cast Stone Cracks, Spalls, Efflorescence

View of cracked, spalled cast stone column. Efflorescence emanates from the mortar joint.

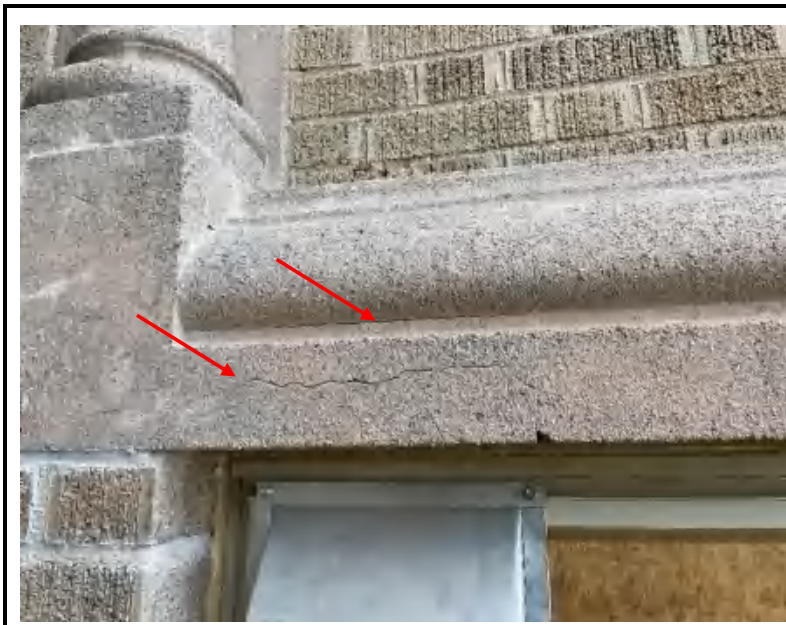
Figure 9

Cracks in Cast Stone

View of cracks in cast stone.

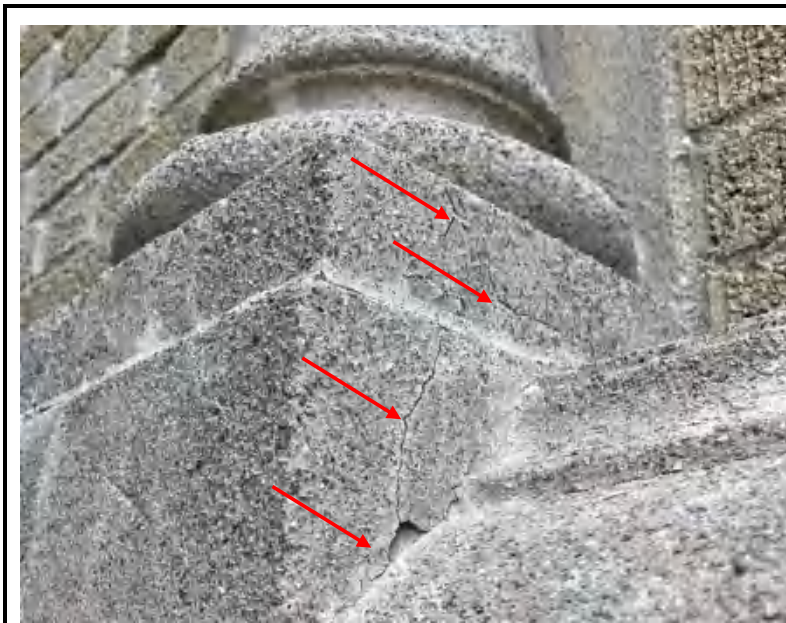
Figure 10

Cracks in Cast Stone

View of cracks and a spall in cast stone.

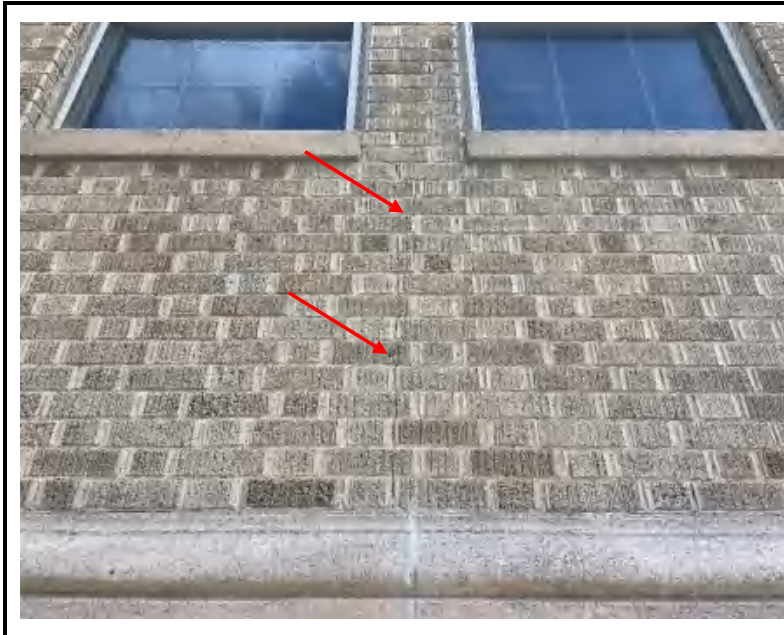
Figure 13

Masonry Wall Cracks

View of vertical crack through section of masonry wall.

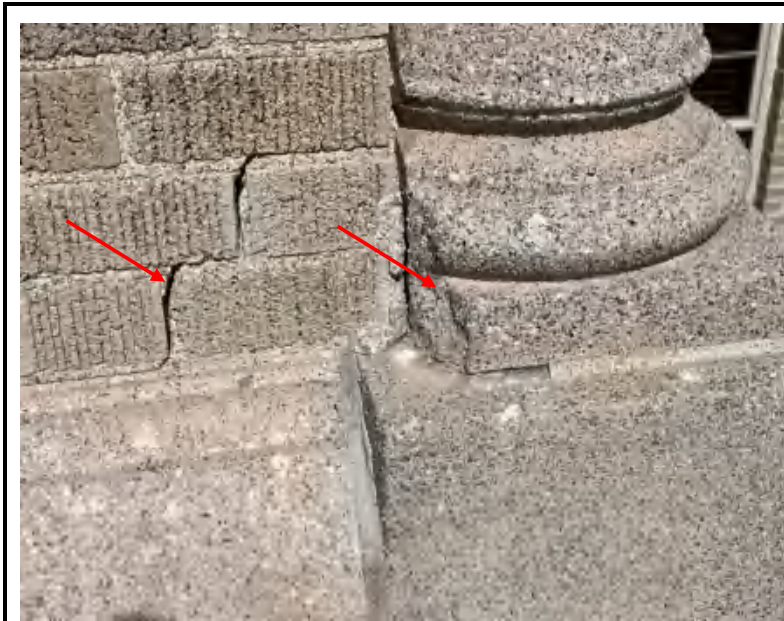
Figure 14

Masonry Wall Cracks

View of cracks in masonry wall. Spalled cast stone with failed mortar joint also seen here.

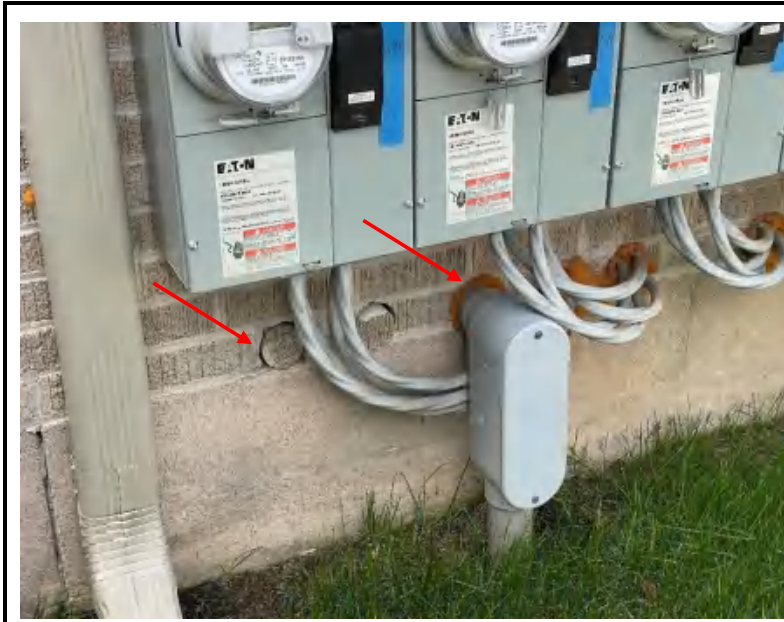
Figure 15

Penetrations in the masonry wall were poorly sealed, or not sealed with cores loosely laid in penetration holes.

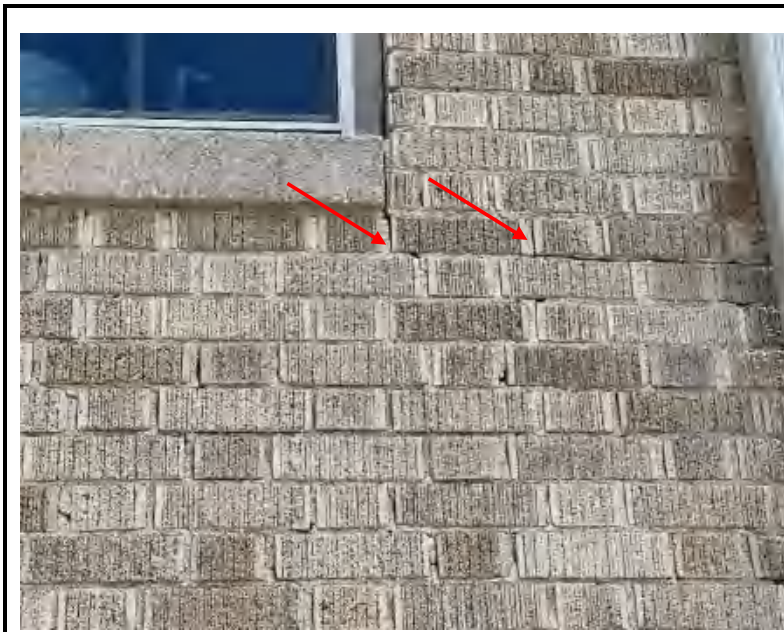
Figure 16

Masonry Wall Cracks and Deteriorated Mortar Joints

View of cracks in a section of masonry wall. Deteriorated and failing mortar joints are also seen in this area.

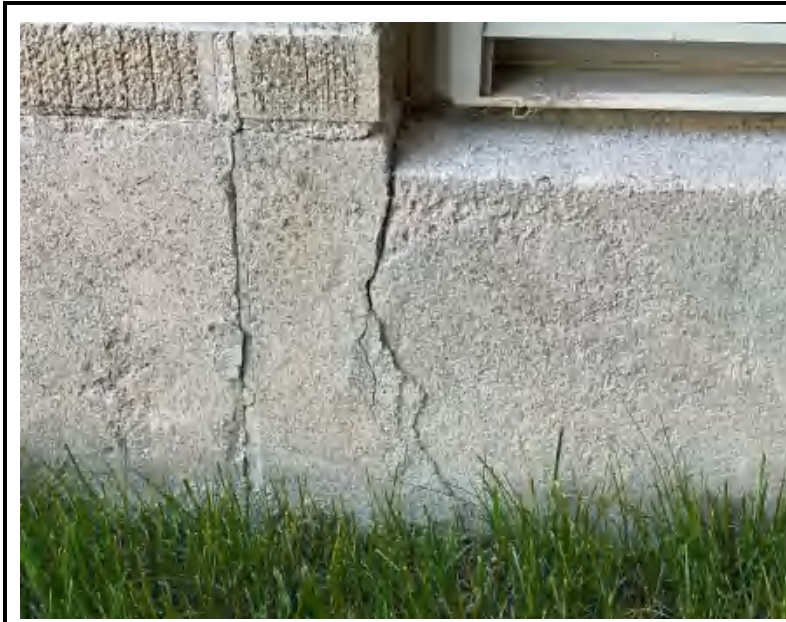
Figure 17

Title:
Cracks in Exposed Foundation

Comments:
View of cracks in the cast stone foundation.

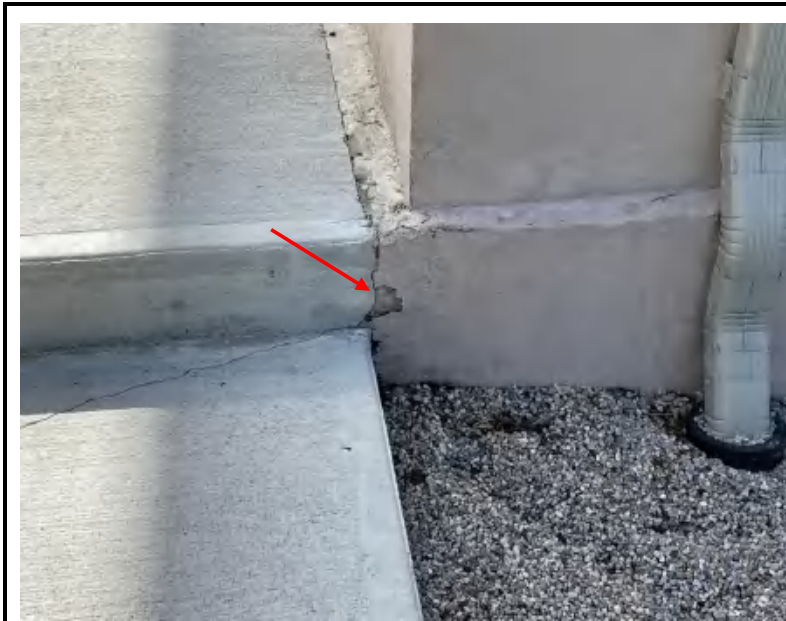
Figure 18

Title:
Spall in Exposed Foundation

Comments:
View of a spall in the cast stone foundation.

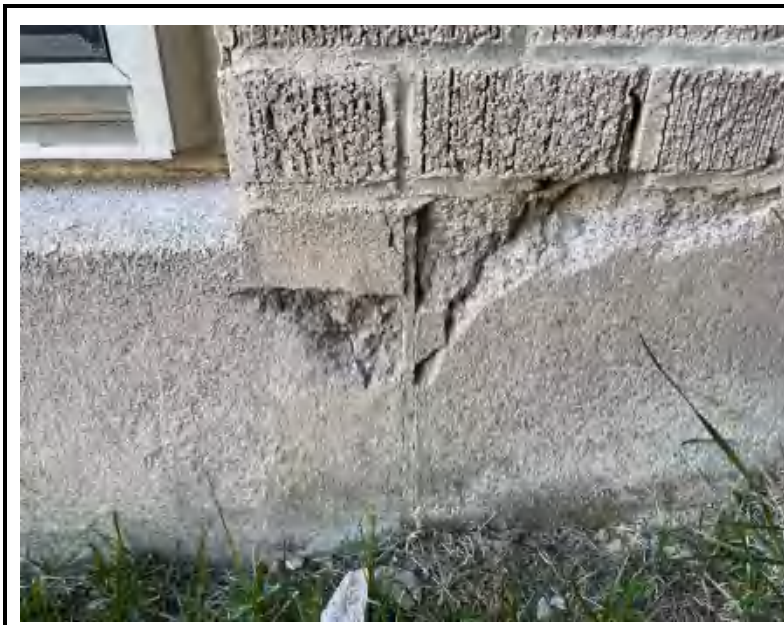
Figure 19

Spalls in Exposed Foundation

View of spalls in the individual cast stone foundation units.

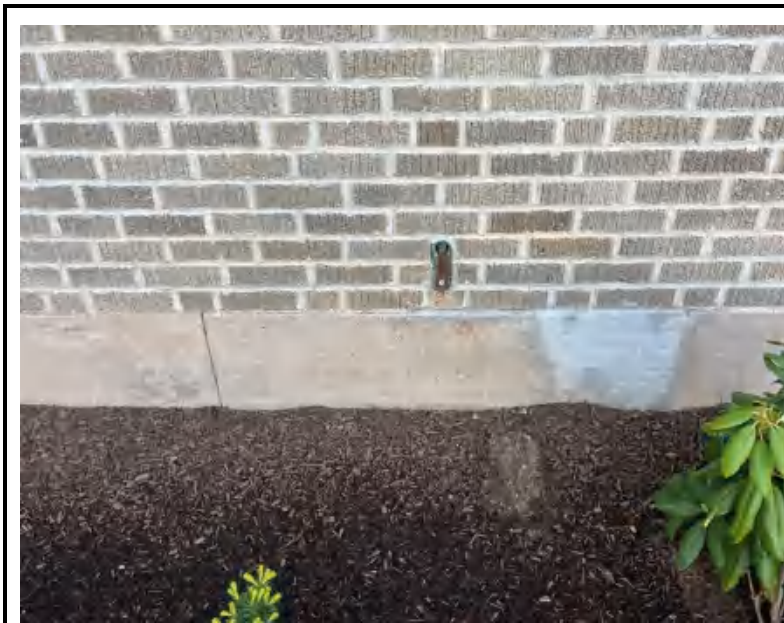
Figure 20

Repaired Exposed Foundation

View of attempted repair in cast stone foundation.

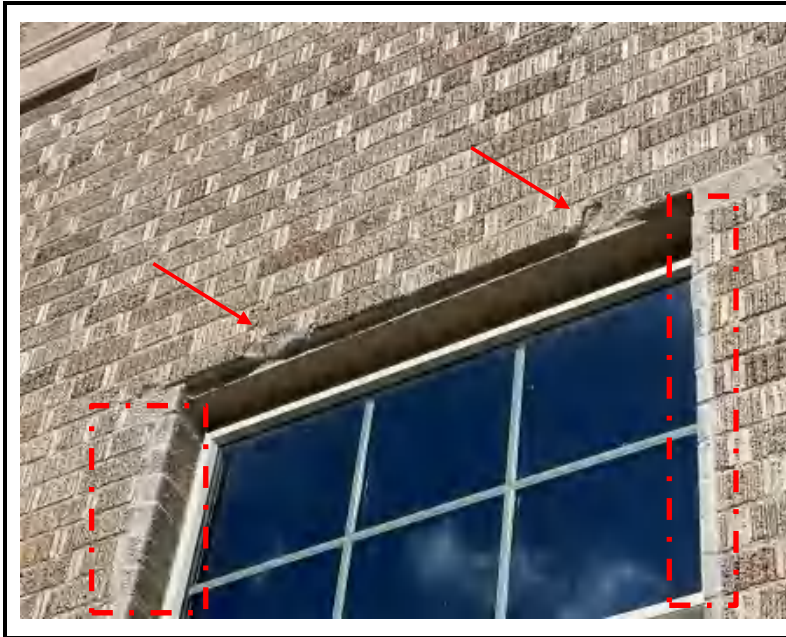
Figure 21

Spalls in Brick Units at Window Lintel

View of spalls in individual brick masonry units above the window lintel. Brick segment infills at the window rough opening also seen here.

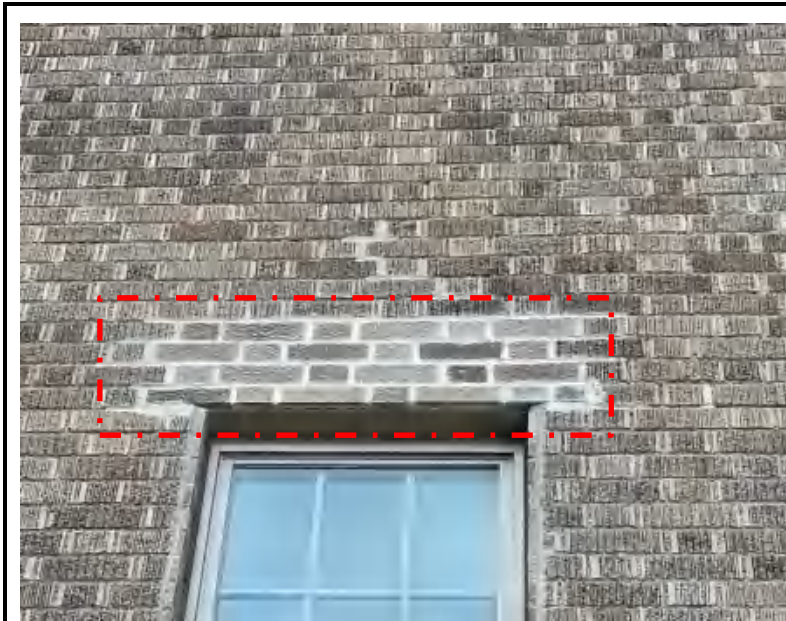
Figure 22

Repaired / Replaced Brick at Window Lintel

View of previously repaired or replaced brick at the window lintel.

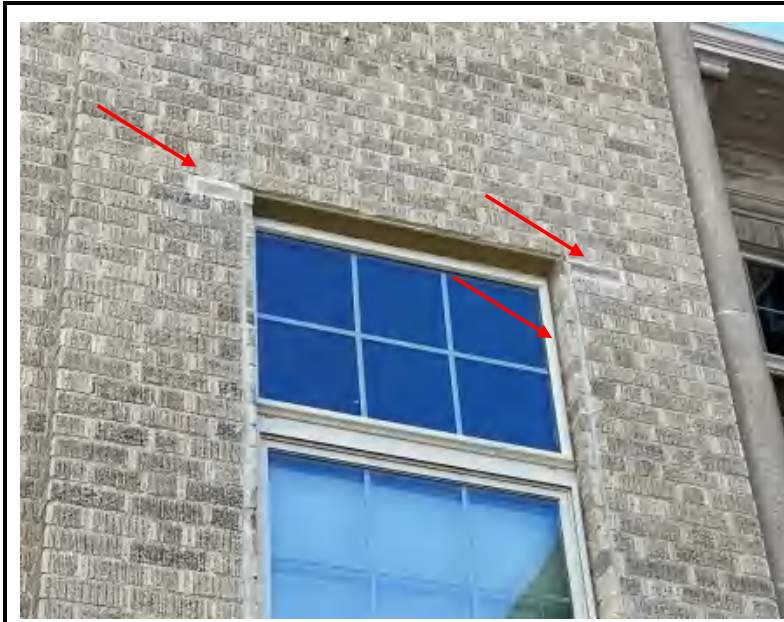
Figure 23

Sealant between the masonry and the window frame was omitted.

View of previously repaired or replaced brick at the window lintel.

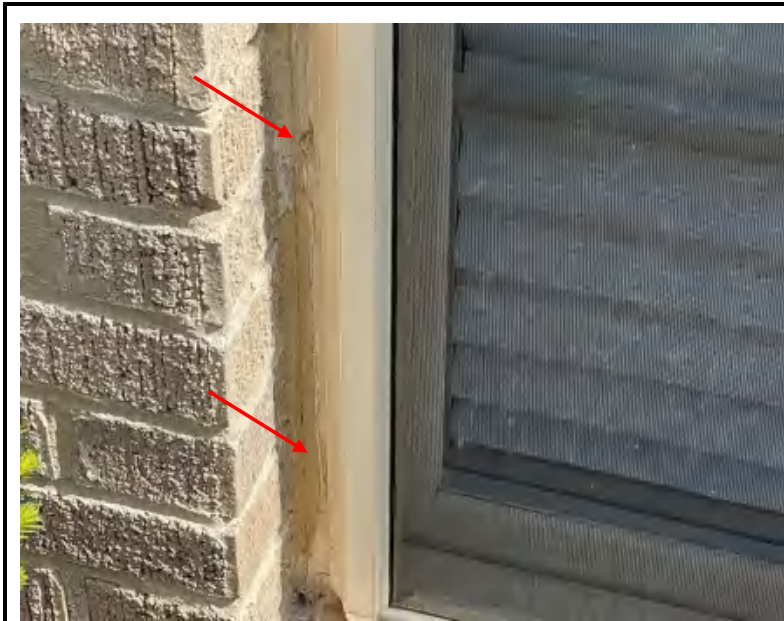
Figure 24

View of improperly installed and failing sealant at window frame.

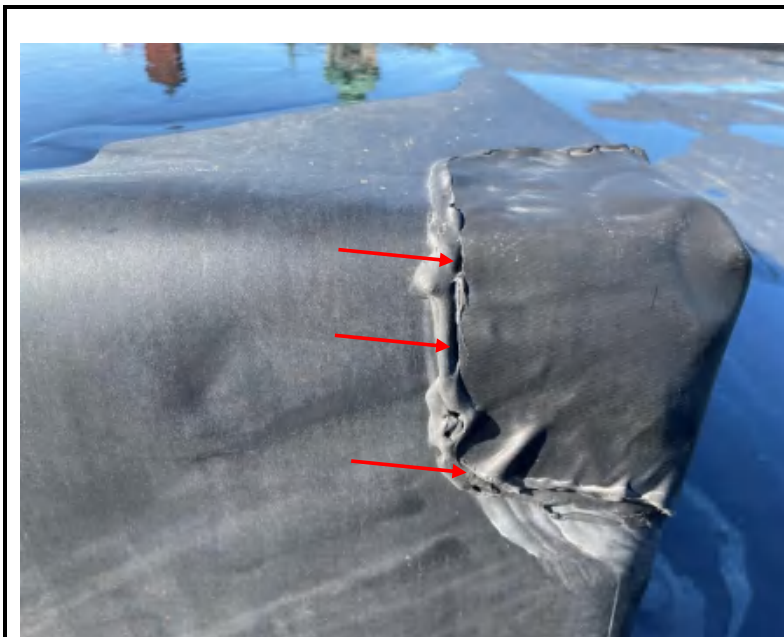
Figure 36

Title:
Failed Sealant at
Corner Patch on
Raised Curb

Comments:
View of a corner patch at
the raised curb. The sealant
around the patch has failed.

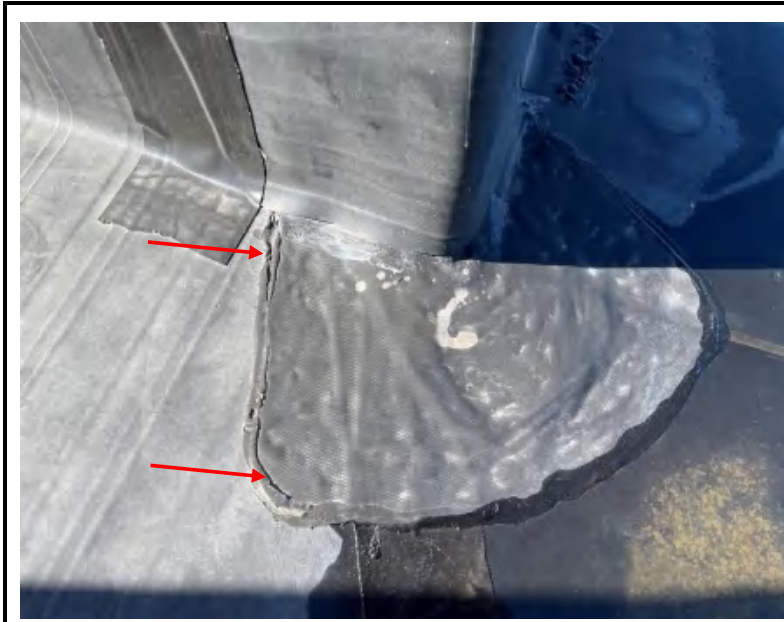
Figure 37

Failed Sealant at Patch at Base of Raised Curb

View of a patch at the base of the raised curb. The sealant around the patch has failed.

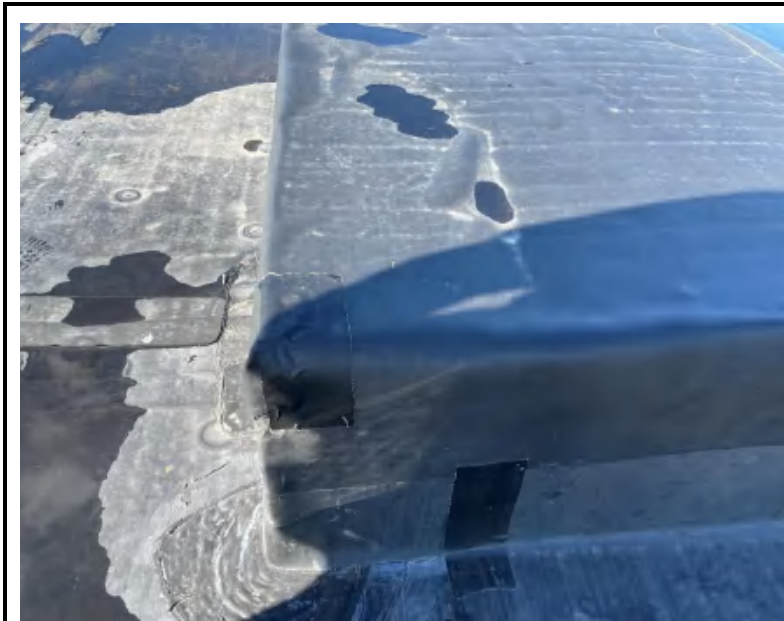
Figure 38

View of flashing tape used as repair patches and seam strips at raised curb.

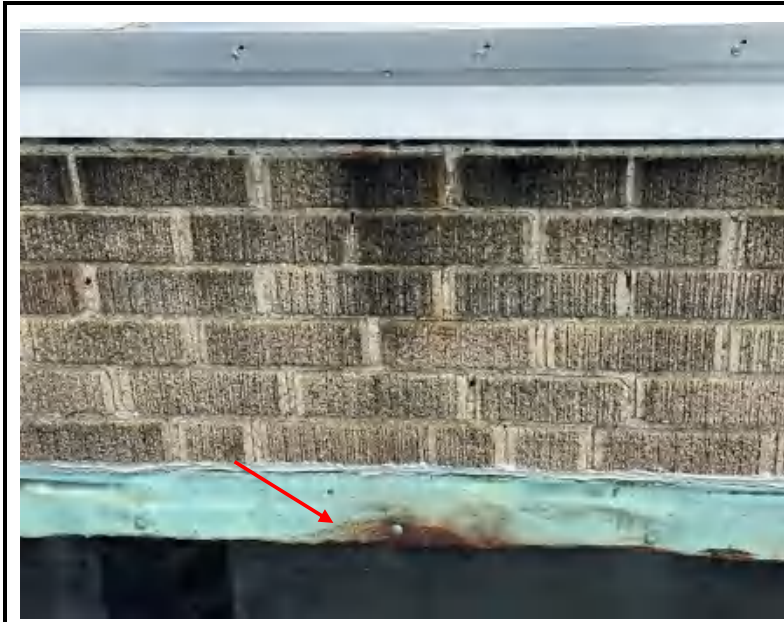
Figure 39

View of stained masonry and deteriorated counterflashing at skylight.

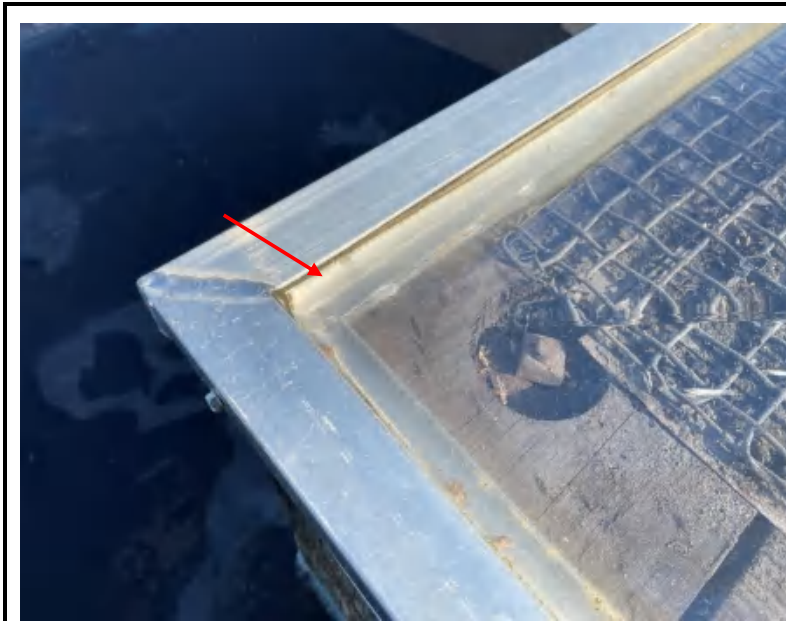
Figure 42

View of the skylight frame, which has been source of water infiltration.

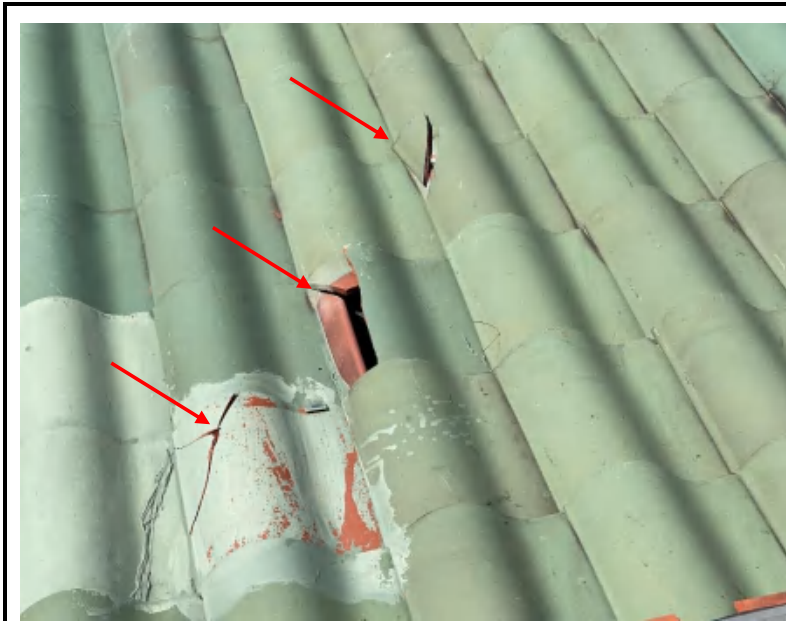
Figure 46

Broken Terracotta
Tiles

View of broken Terracotta
tiles. Tile damage is
widespread

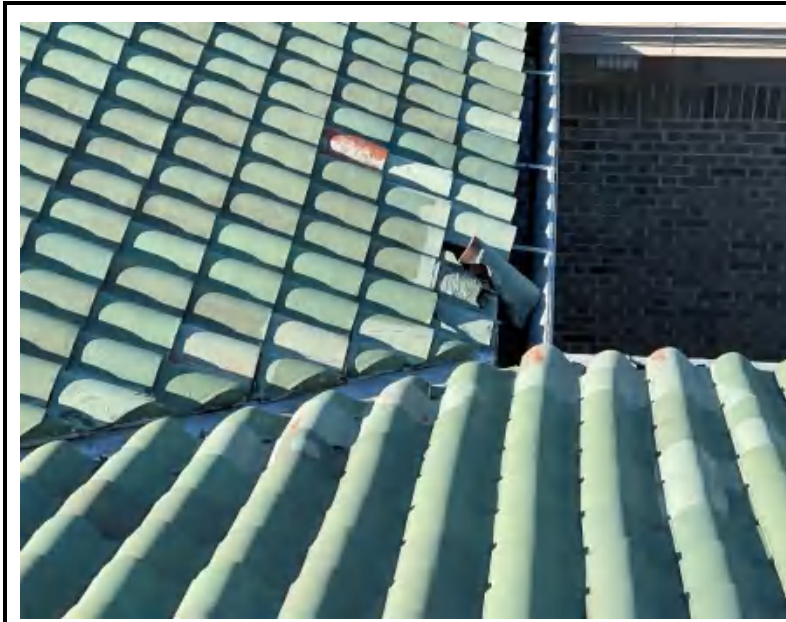
Figure 47

Broken Terracotta Tiles

View of broken Terracotta tiles.

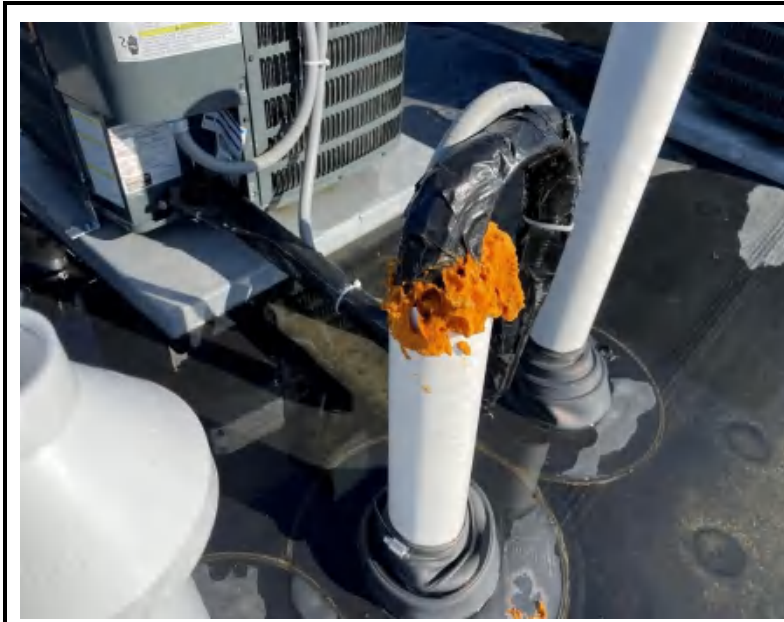
Figure 53

Foam-Plugged Roof
Loose Penetration

View of roof penetrations improperly filled with foam rather than a pitch pocket or approved flashing. The PVC pipe is not fastened or secured below. The boot flashing has collapsed. The PVC pipe is being pulled down by the weight of the pipe and the conduit.

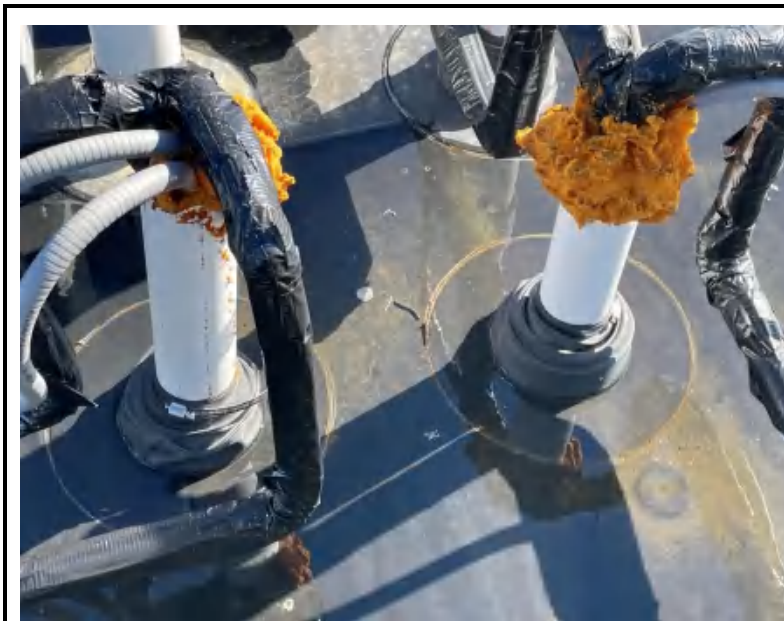
Figure 54

Foam-Plugged Roof
Loose Penetration

View of roof penetrations improperly filled with foam rather than a pitch pocket or approved flashing. The PVC pipe is not fastened or secured below. The boot flashing has collapsed. The PVC pipe is being pulled down by the weight of the pipe and the conduit.

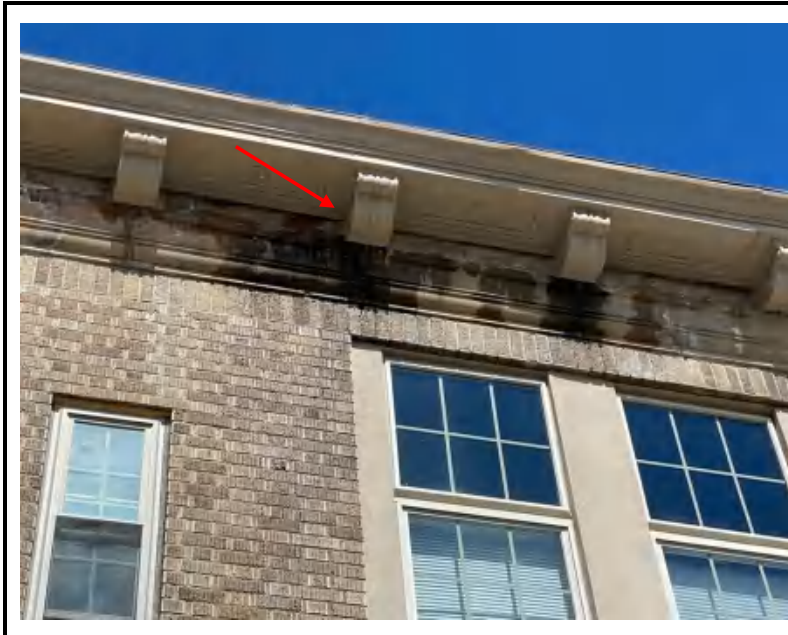
Figure 61

Water Test Results and Exterior Condition

Water was observed permeating through the cast stone units and through the underside of the gutter soffit. Leaks were observed within 30 minutes of the start of the 90 minute testing.

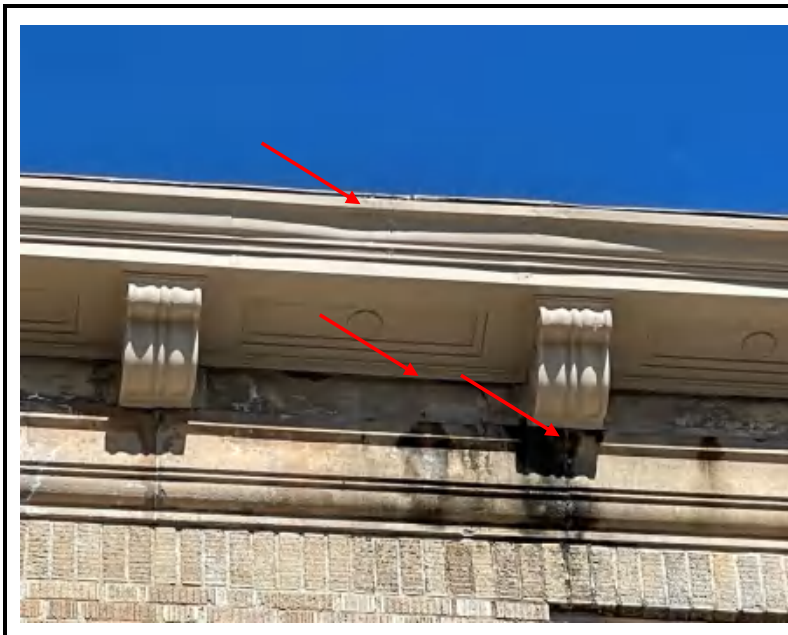
Figure 62

Water Test Results and Exterior Condition

View of water running over the gutter, behind the gutter, and through the cast stone during water test.

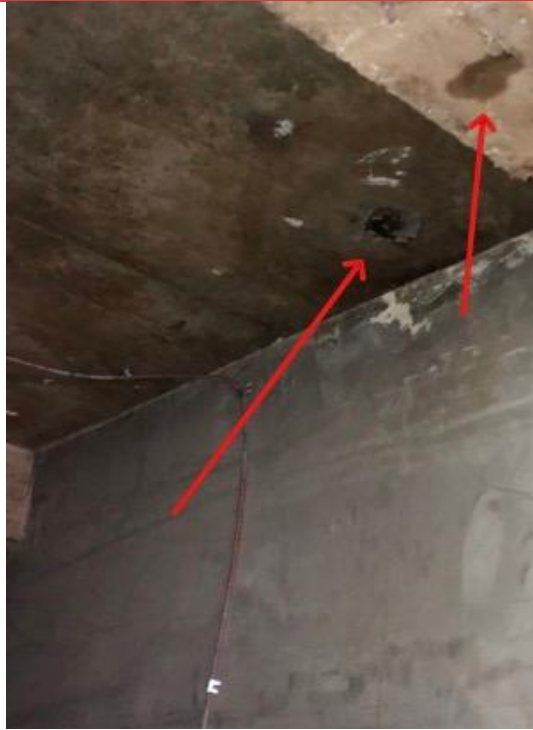
ISSUE 7

Notice water penetrating the roof and entering near elevator shaft.

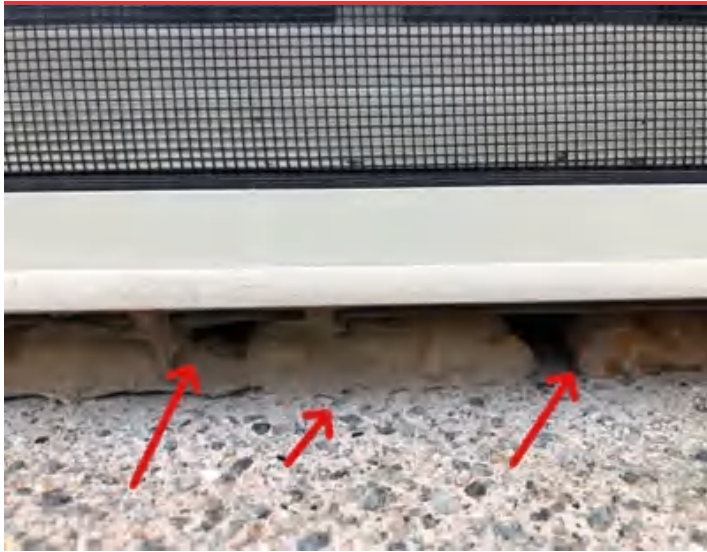
FIRST FLOOR WINDOW

This was supposedly repaired by developer. This is unacceptable. Not sealed properly.

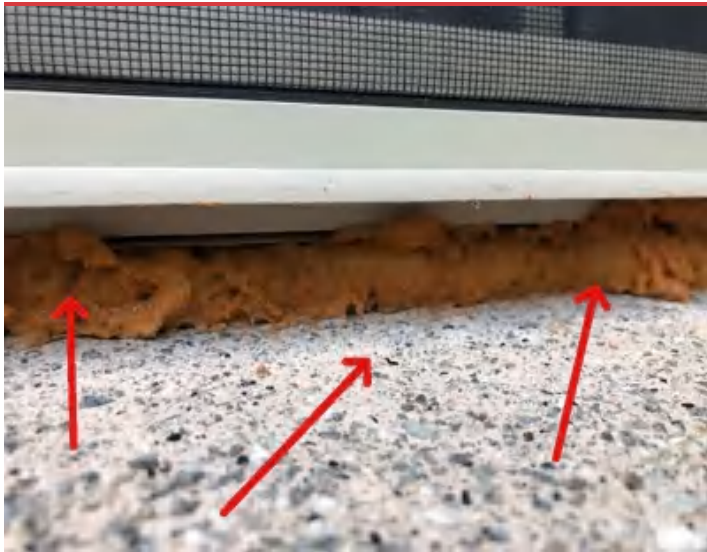
FIRST FLOOR WINDOW

Supposedly sealed by developer. They used spray foam which does not seal the window properly. And it's no wonder there are issues closing windows.

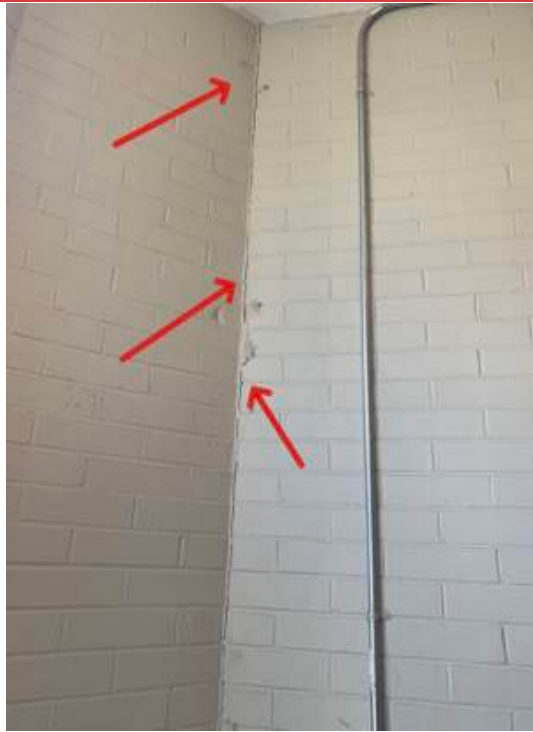
ISSUE 21

Fill cracks in bricks and paint to prevent further damage.

Done

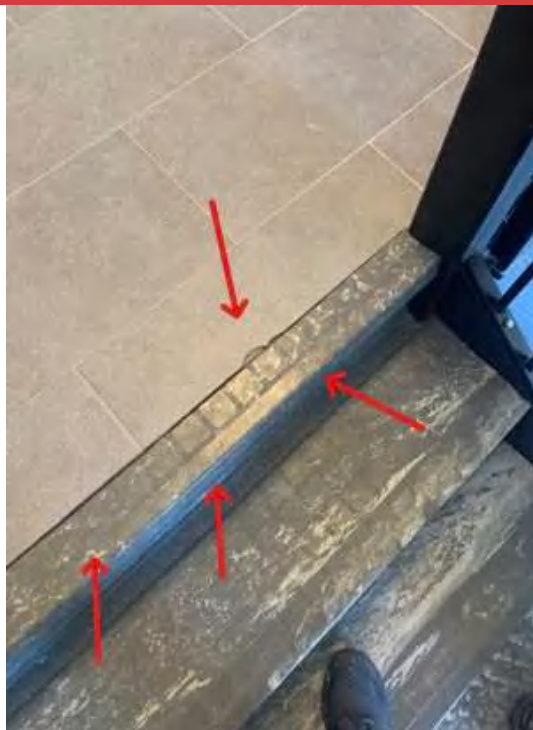
ISSUE 22

Locust street stairwell: chipped tile and dangerously loose tread. Needs to be repaired.

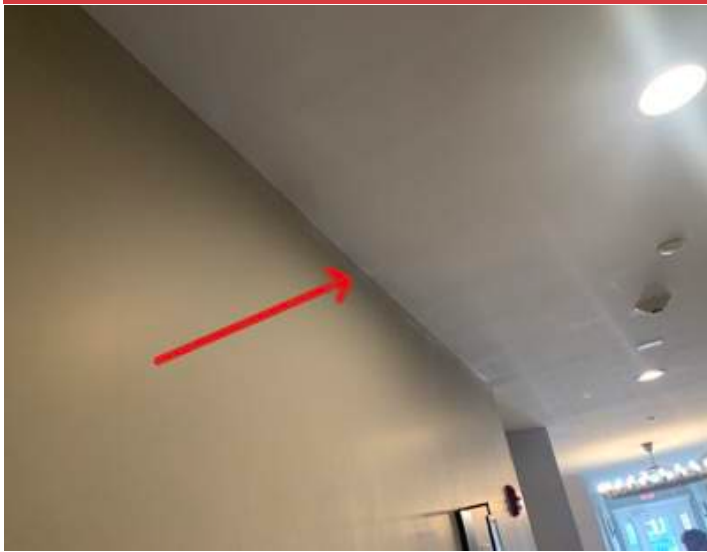
ISSUE 25

Hallway walls need additional coat of paint to eliminate "holidays".

This was a wishlist item.
Not done.

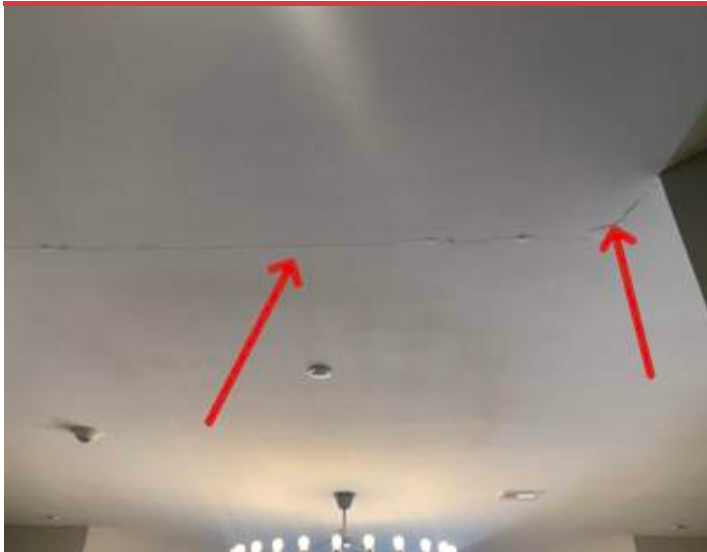
ISSUE 26

Large crack in ceiling outside elevator on 2nd floor. Needs repair.

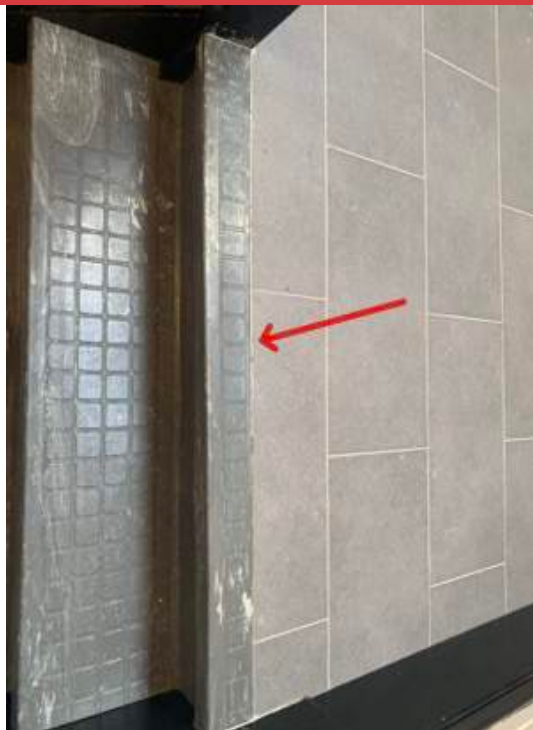
ISSUE 30

The third floor tread is loose and dangerous on the Church side stairwell.

Done

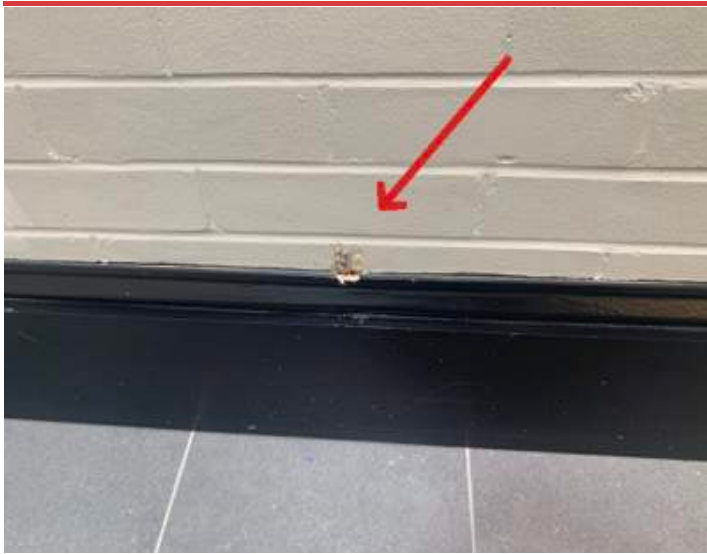
ISSUE 31

Strange wire cut and exposed in 3rd floor stairwell on church side.

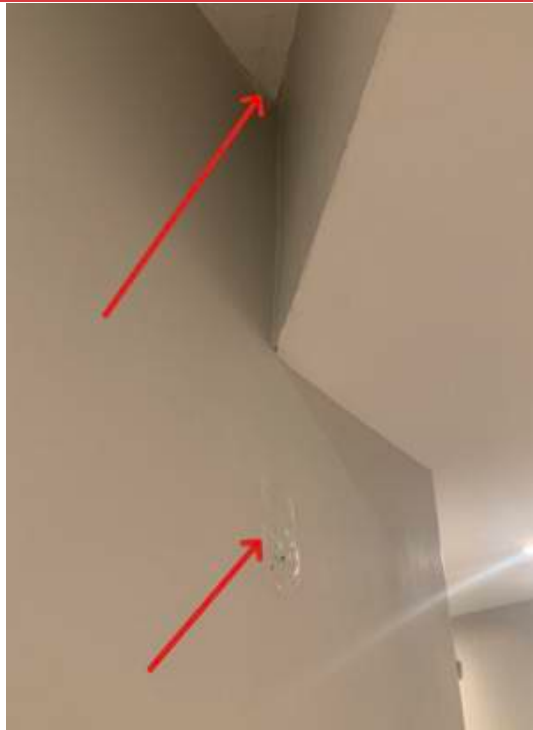
ISSUE 35

Apparent roof leak that has caused damage and needs repair just outside elevator

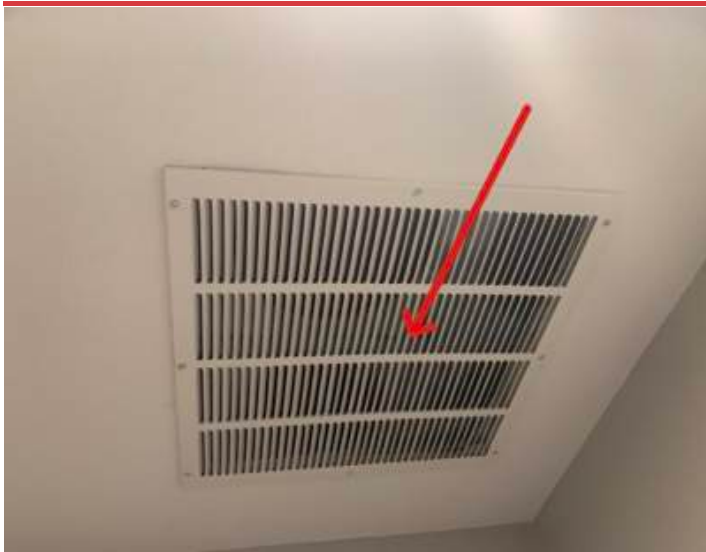
ISSUE 37

It appears that filters are not in place which can cause damage to the HVAC units. This is the case in all common area intakes.

Done

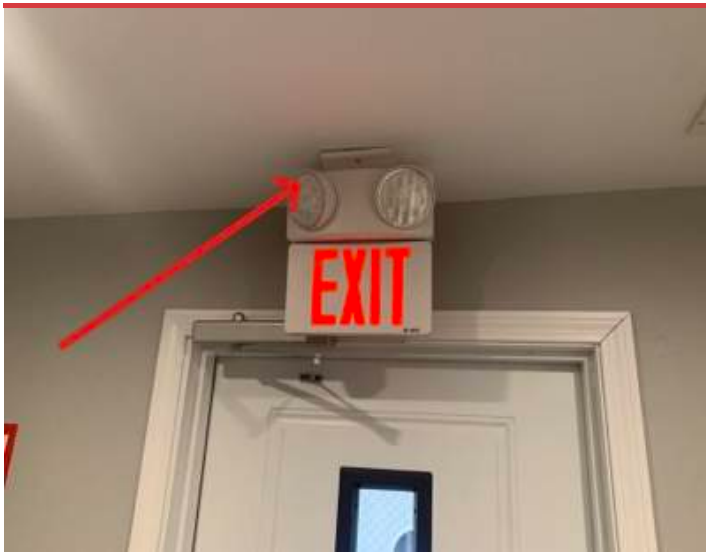
ISSUE 38

Exit sign has been hit and needs to be re-anchored to the ceiling properly

Done

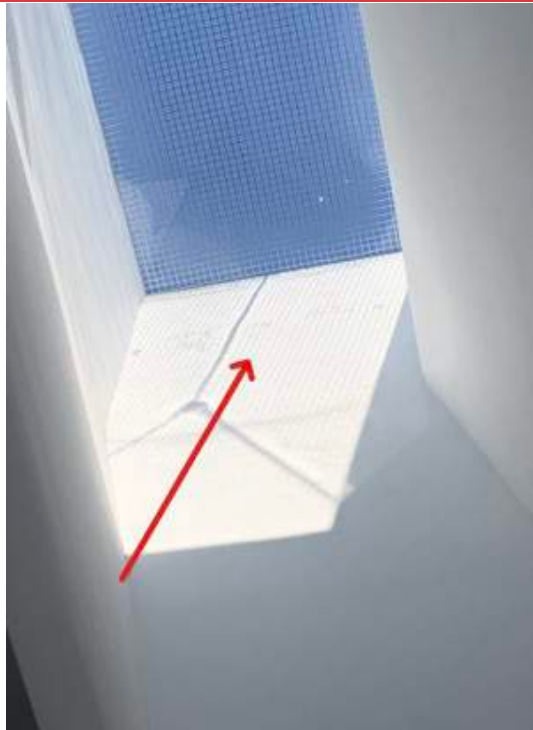
ISSUE 39

Evidence of leaks to church side skylight.

Looks better.

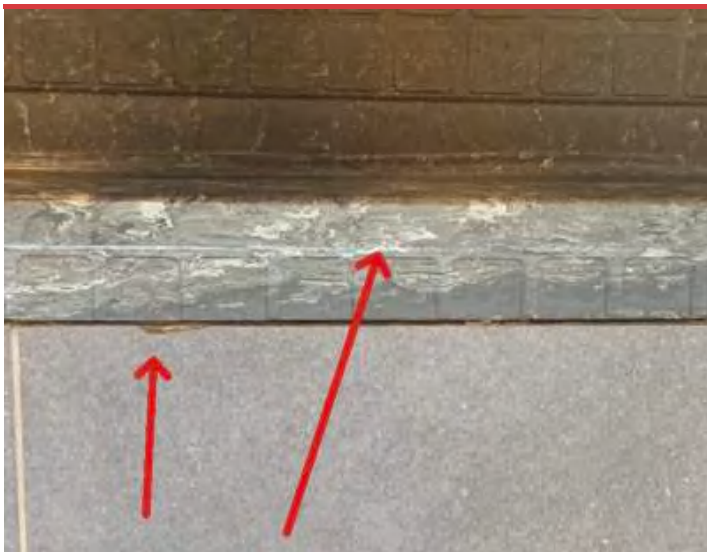
ISSUE 40

Church side. Loose to tread and chipped tile.

Acceptably repaired

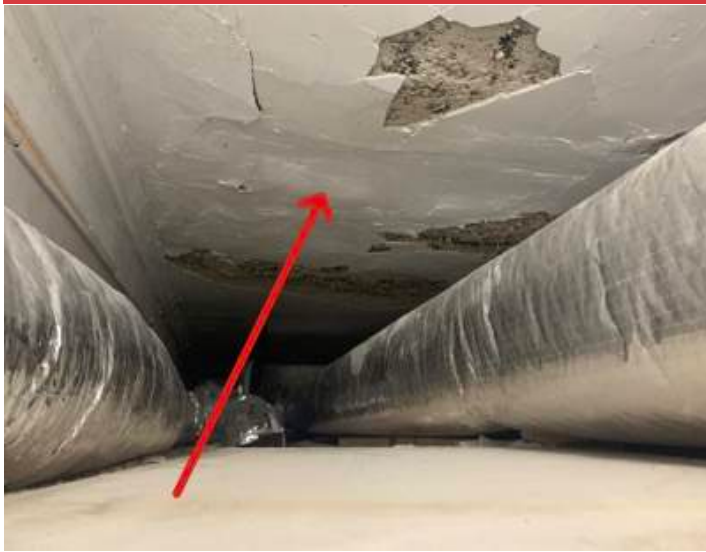
ISSUE 41

Crawl space above locust side on 3rd floor. Ceiling is falling and debris will damage duct work and hvac units.

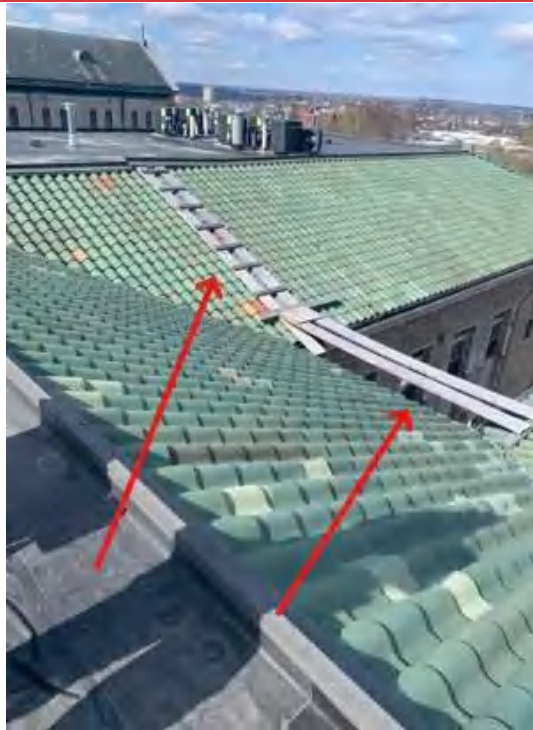
ISSUE 49

Scaffolding needs to be removed before it falls. Tile roof needs many repairs.

Many repairs have been made. Roof looks better but still many major issues regarding missing or broken tiles and open seams.

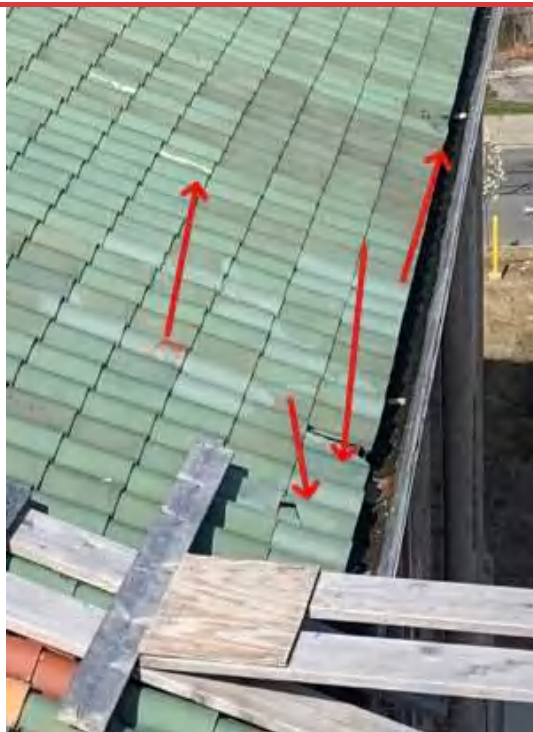
ISSUE 50

Tile roof needs immediate repairs.

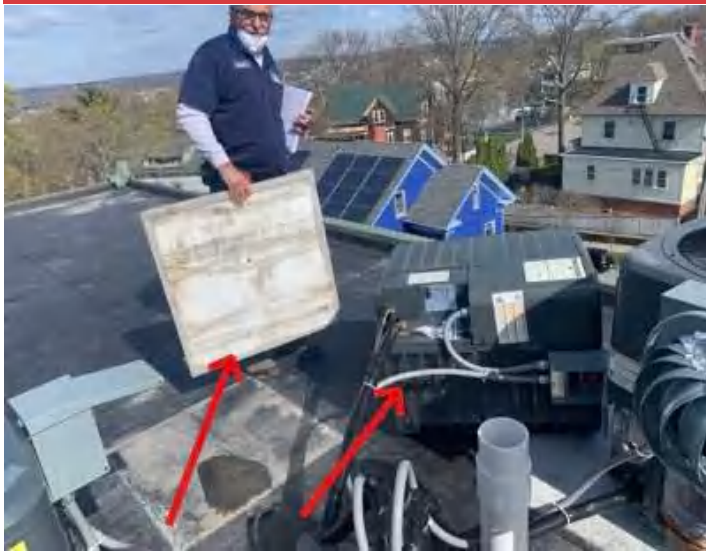
ISSUE 51

Pads are too light and not anchored. Hvac units are not anchored. Has blown over causing extremely dangerous problem. Unit will not function.

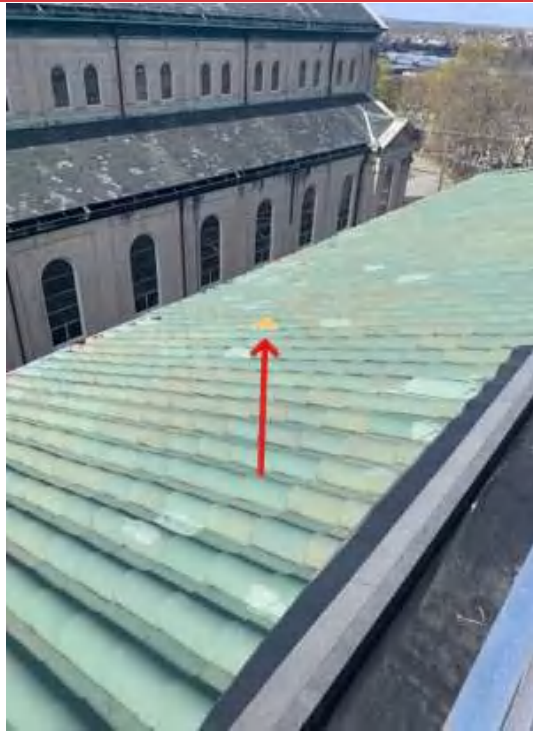
ISSUE 53

Tile roof has spray foam to apparently stop leaks. Roof needs immediate repairs

Still as pictured.

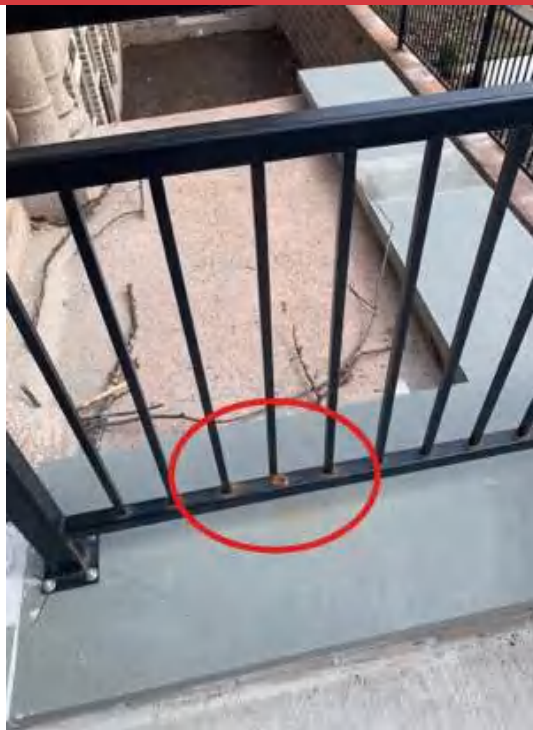
ISSUE 54

Front railing needs welding repair and paint.

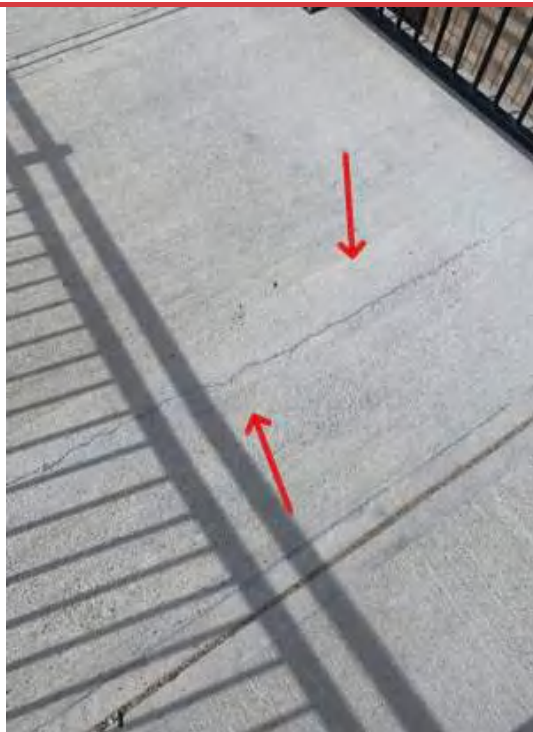
ISSUE 58

Repair cracked concrete before it gets worse.

AMS can easily fix this.

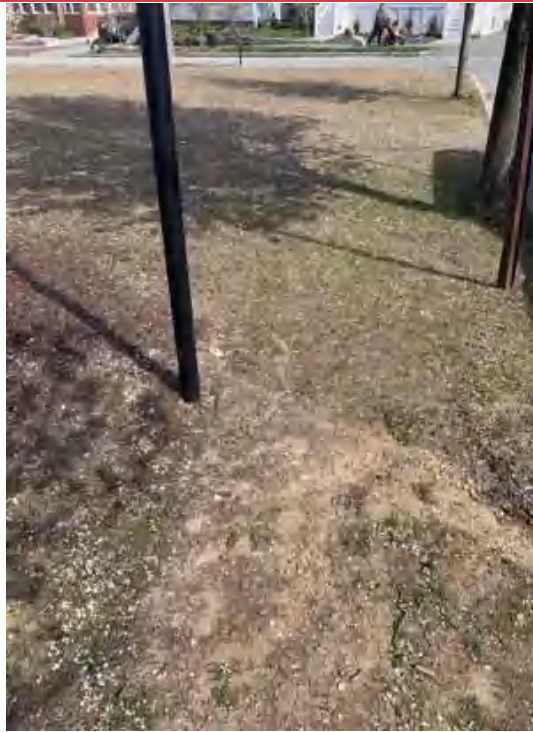
ISSUE 59

Lawn areas need screened loam added to fill eroded areas and re-seed entire lawn. It was seeded too late in the season.
