Chapel Hill East Condominium
Documents Relating to Construction Issues

Current 06/07/2023

CONDITION ASSESSMENT REPORT

Building Enclosure Science, LLC (BES) was commissioned by Acropolis Management Services (Acropolis) to perform a condition assessment of the building envelope at 7 Mount Hope Avenue, Providence, RI.

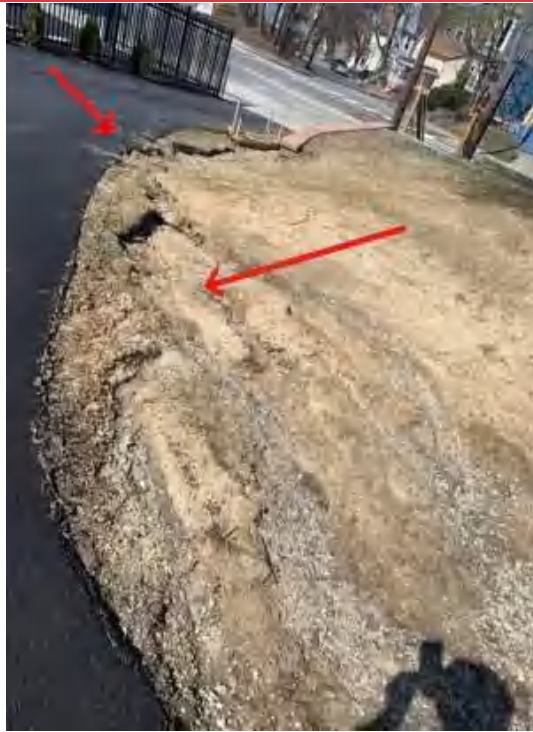
ISSUE 71

Additional erosion problems that are now creating asphalt problems that need to be repaired
