Chapel Hill East Condominium
Documents Relating to Construction Issues

Current 06/07/2023

CONDITION ASSESSMENT REPORT

Building Enclosure Science, LLC (BES) was commissioned by Acropolis Management Services (Acropolis) to perform a condition assessment of the building envelope at 7 Mount Hope Avenue, Providence, RI.

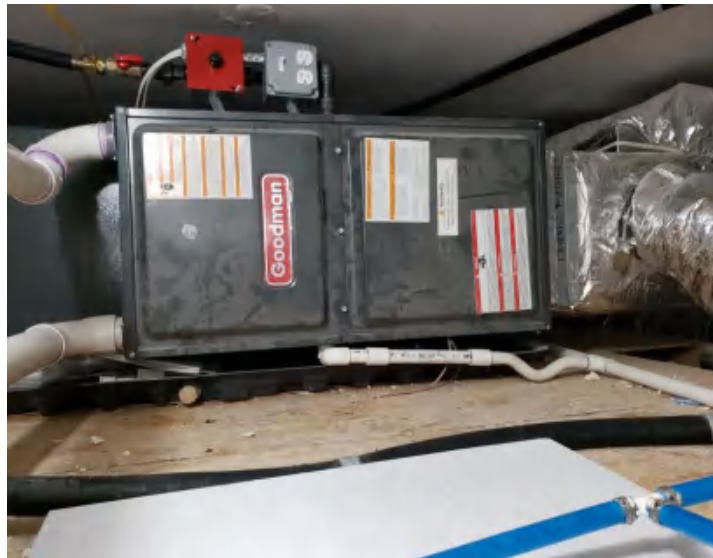
Fireplace Ductwork (Uninsulated sheet metal duct in back)

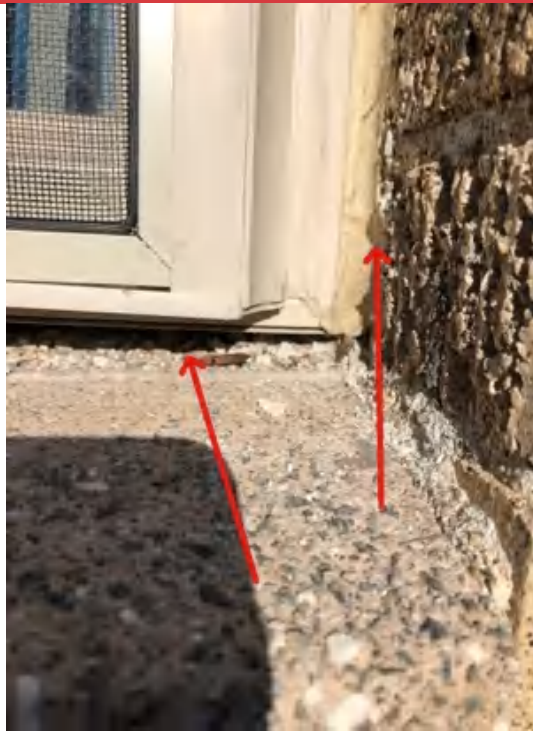
WINDOW AS OF 1/5/21
Completely open and unsealed.

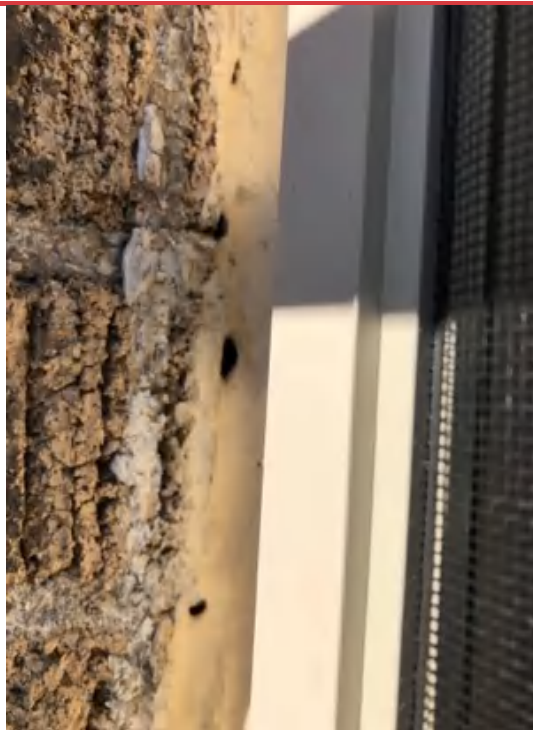
CLOSE UP TO SHOW HOLES
Large holes in caulk.
Poorly installed.
