Chapel Hill East Condominium
Documents Relating to Construction Issues

Current 06/07/2023

CONDITION ASSESSMENT REPORT

Building Enclosure Science, LLC (BES) was commissioned by Acropolis Management Services (Acropolis) to perform a condition assessment of the building envelope at 7 Mount Hope Avenue, Providence, RI.

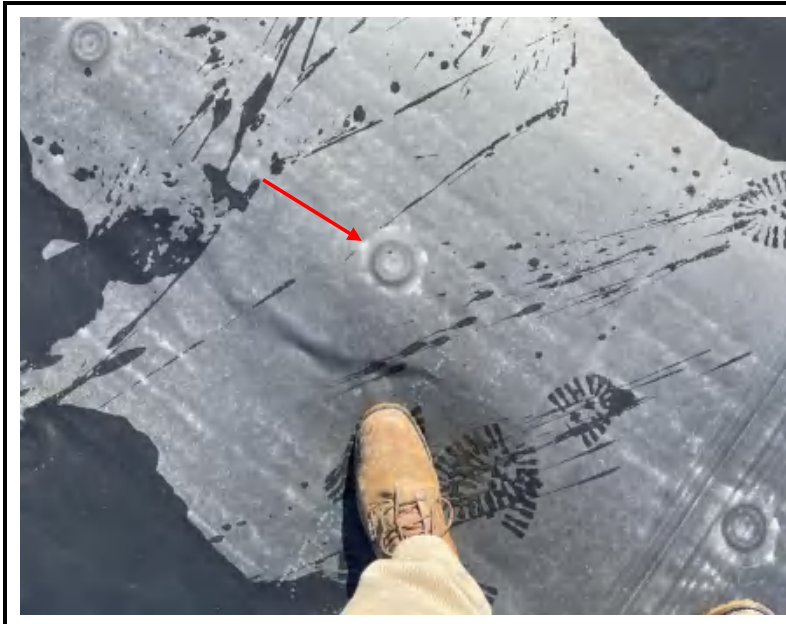
Figure 29

View of mechanical insulation fastener pushing on backside of EPDM roof membrane.

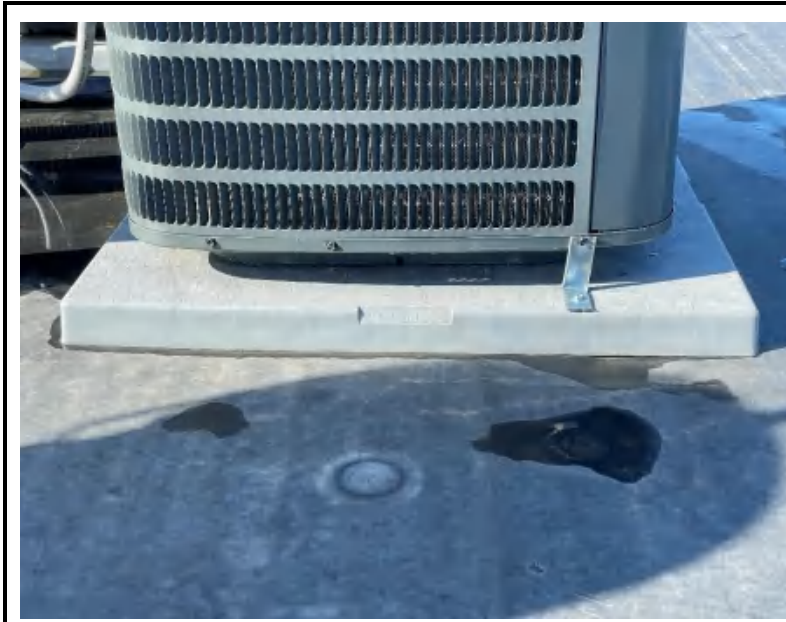
Figure 33

View of HVAC unit fastened to an unweighted curb.

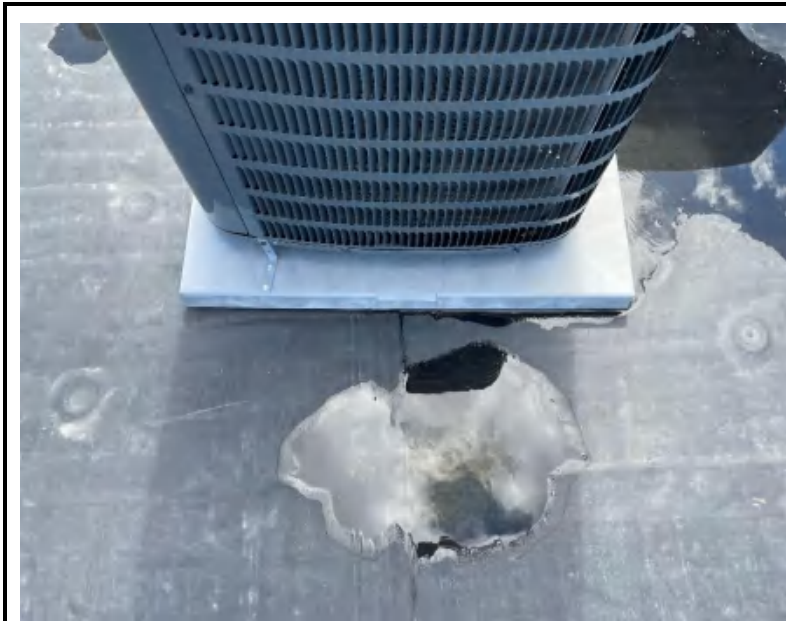
Figure 34

View of HVAC unit fastened to an unweighted curb.

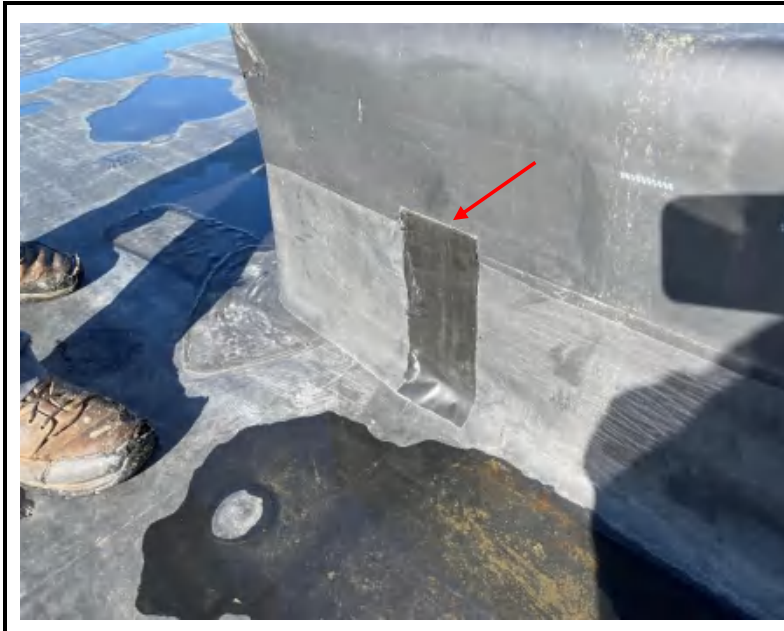
Figure 35

Title:
Rasied Curb with
Flashing Tape

Comments:
View of seam in raised curb
patched with flashing tape.
In addition, the tape is
improperly lapped.

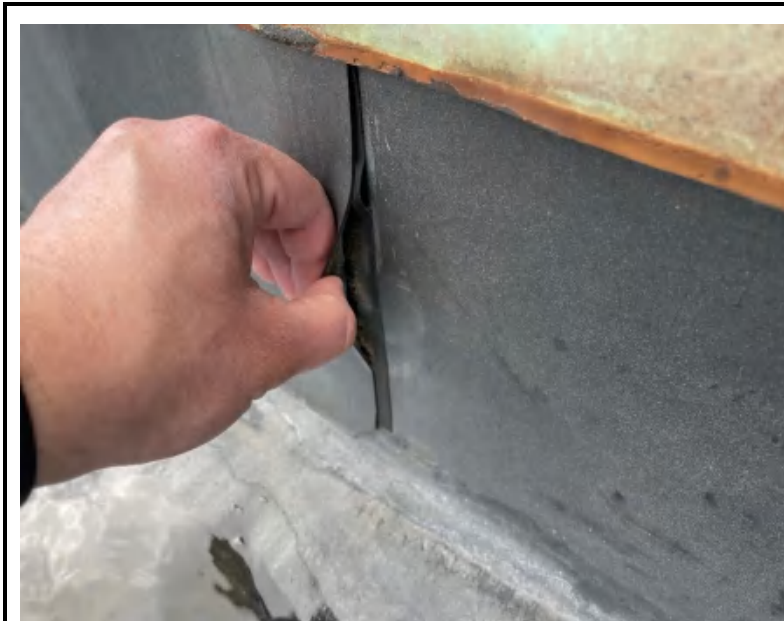
Figure 40

Open seam in membrane flashing

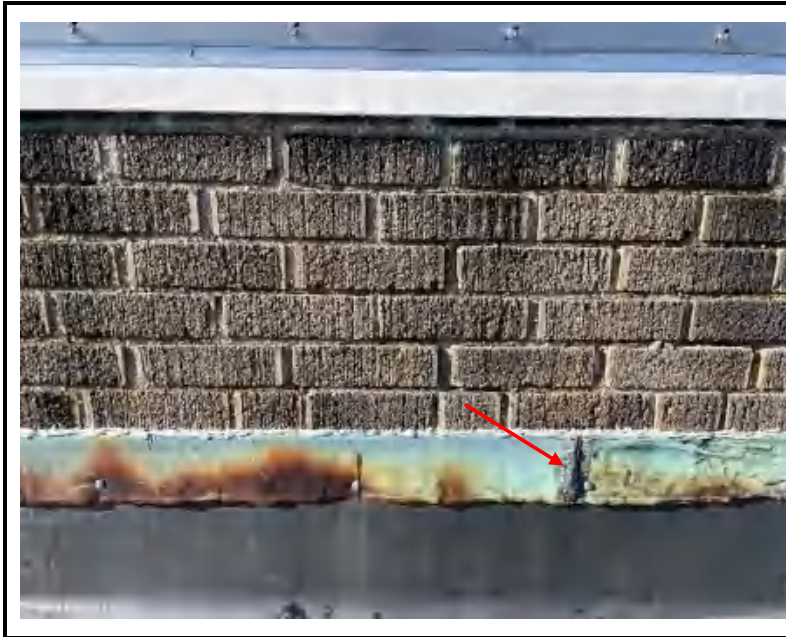
Figure 41

View of stained masonry and deteriorated counterflashing at skylight.

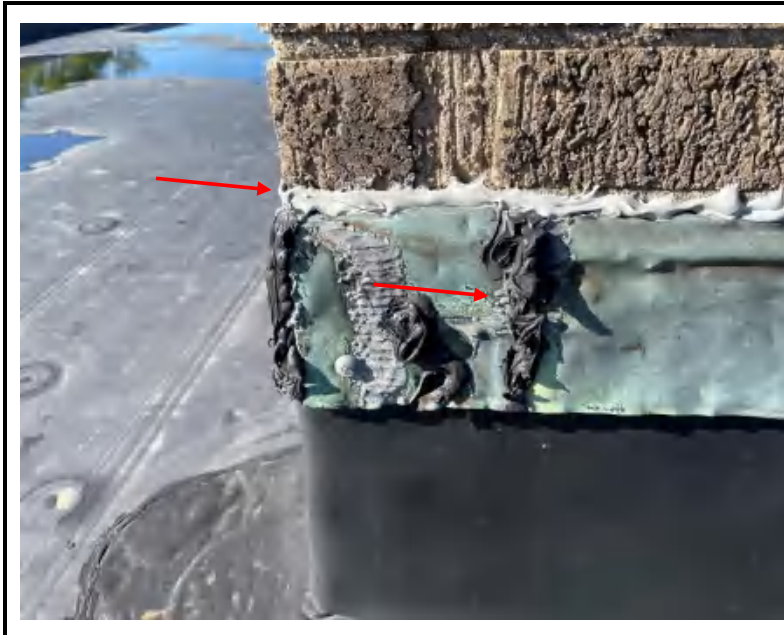
Figure 49

View of the deteriorated chimney counterflashing. Broken weld joints are sealed, and the termination sealant above has failed.

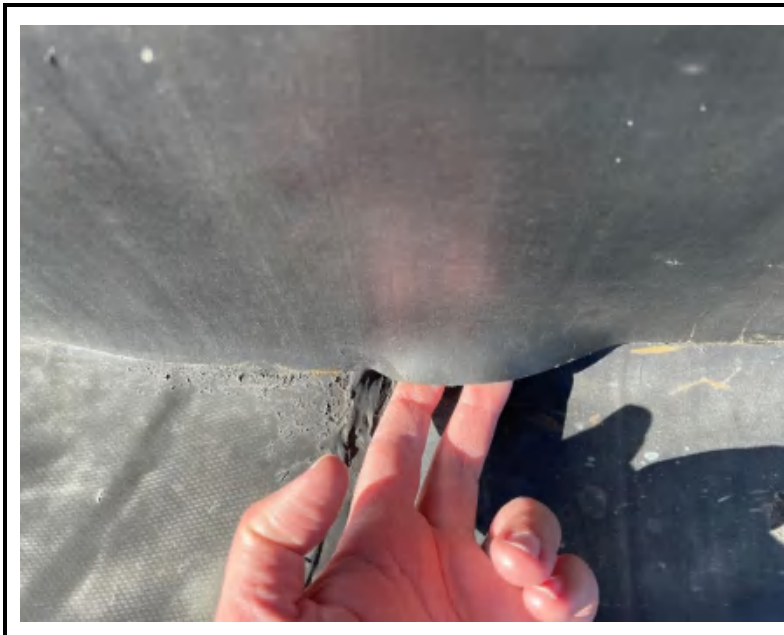
Figure 50

View of the unsealed chimney membrane flashing.

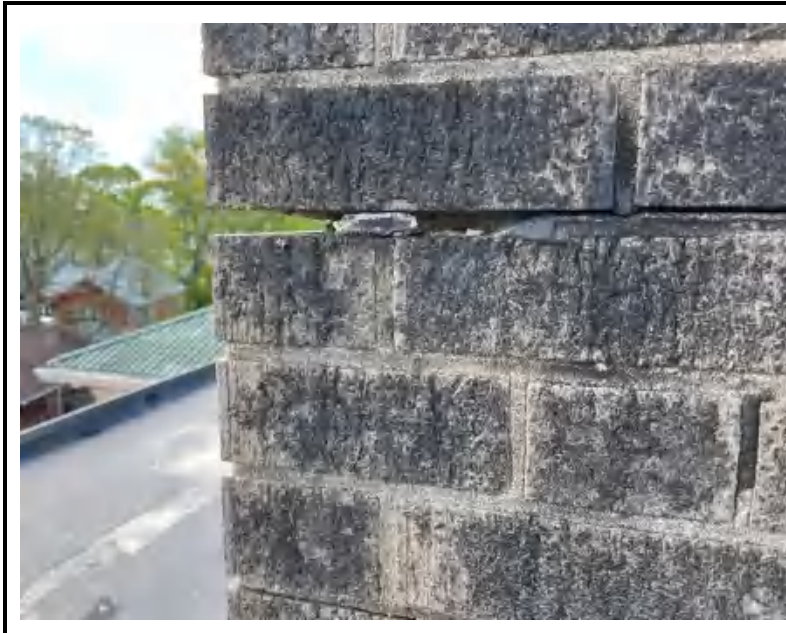
Figure 51

Viewed of washed out and missing mortar joints in the chimney's masonry.

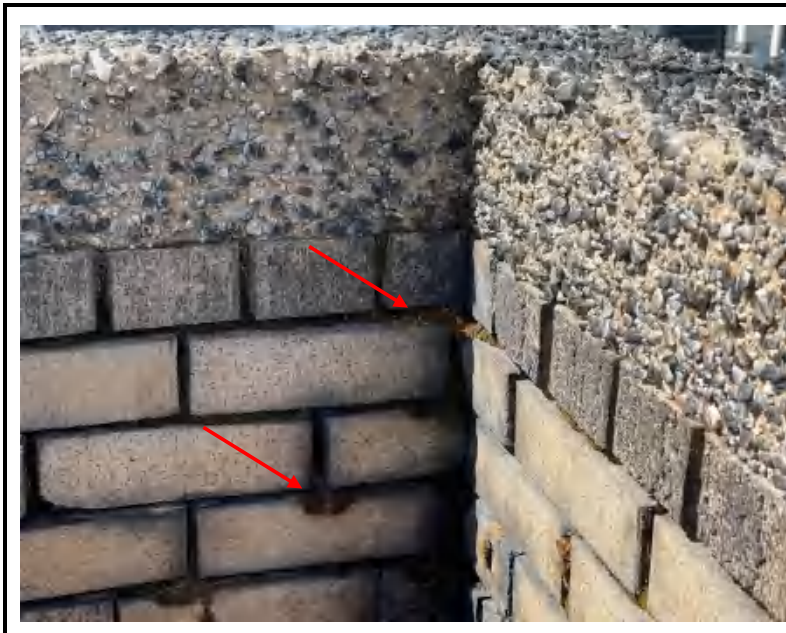
Figure 52

View of missing internal mortar joints. Organic debris has grown in the washed out joints.

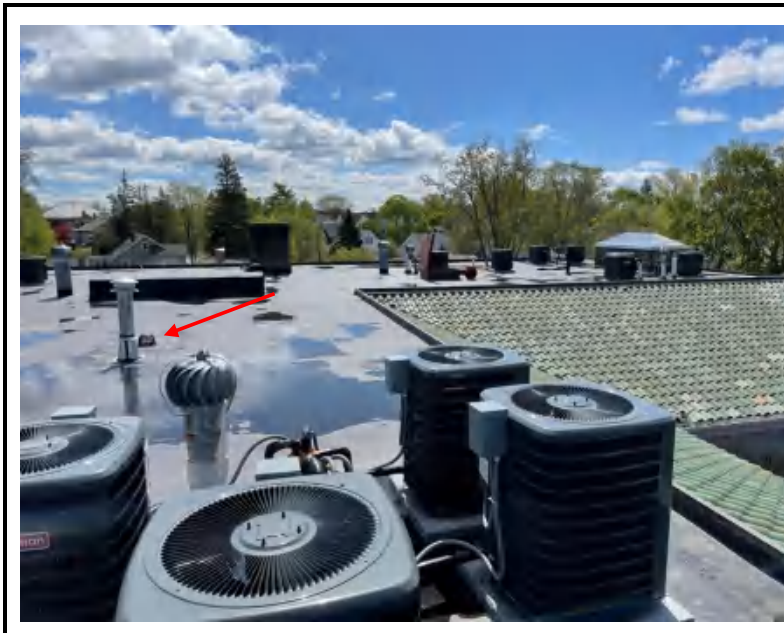
Figure 56

Partial view of roof field, with ponding around internal roof drain.

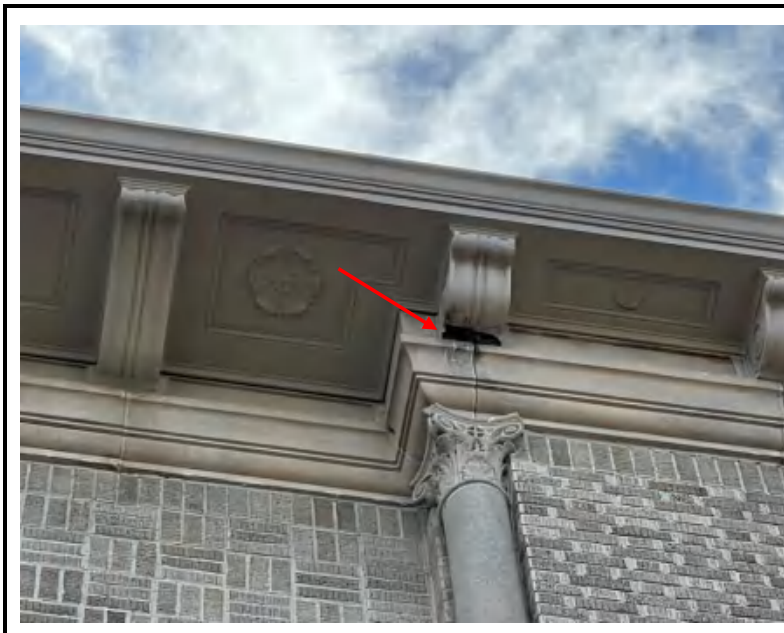
Figure 58

View of opening in cast stone beneath bracket where a bird has nested.

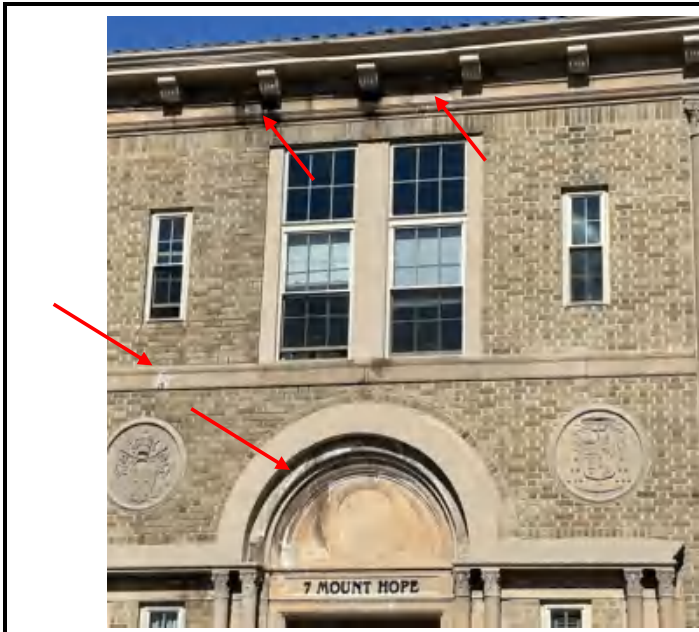
Figure 60

Exterior Conditions Below Test Area

Severe deterioration of the cast stone has resulted from reported and documented water leaks above the front entrance at the roof level.

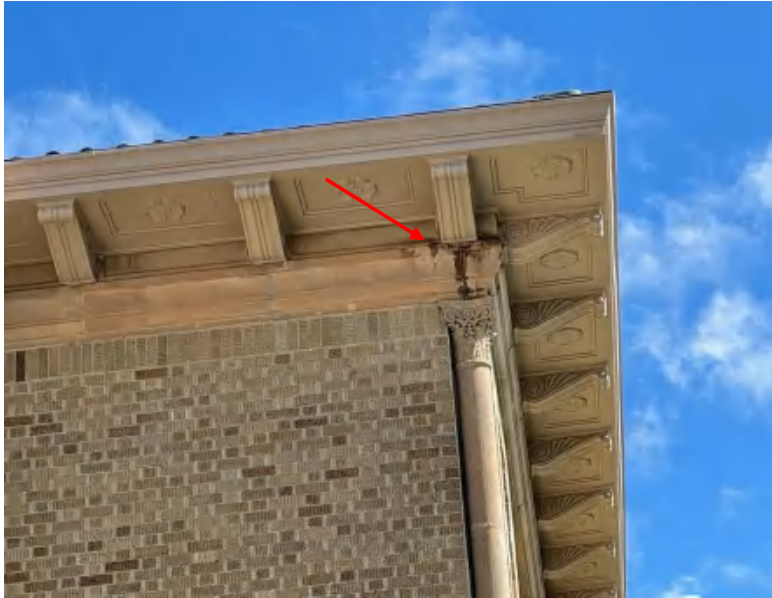
<p>Figure 63</p>
	<p><u>Title:</u> Water Test Results and Exterior Condition</p>
	<p><u>Comments:</u> View of water emanating through joints between cast stone units beneath the gutter during water testing.</p>

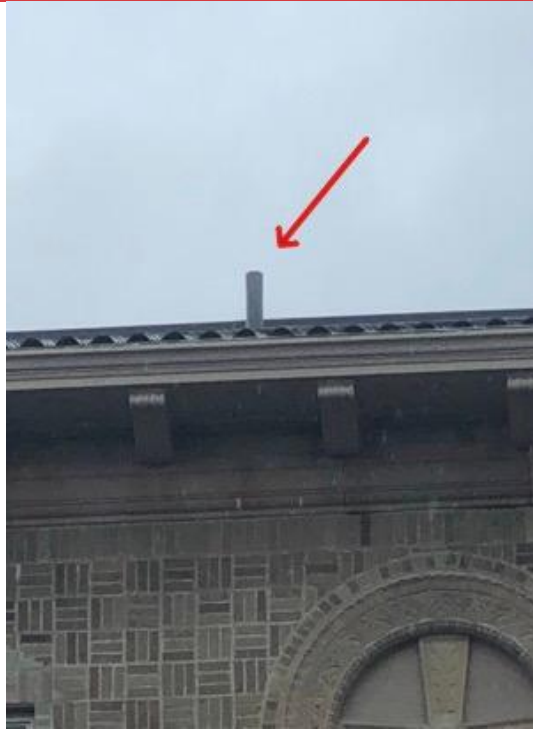
ISSUE 1

Old cast iron drain vent still penetrating clay tile roof

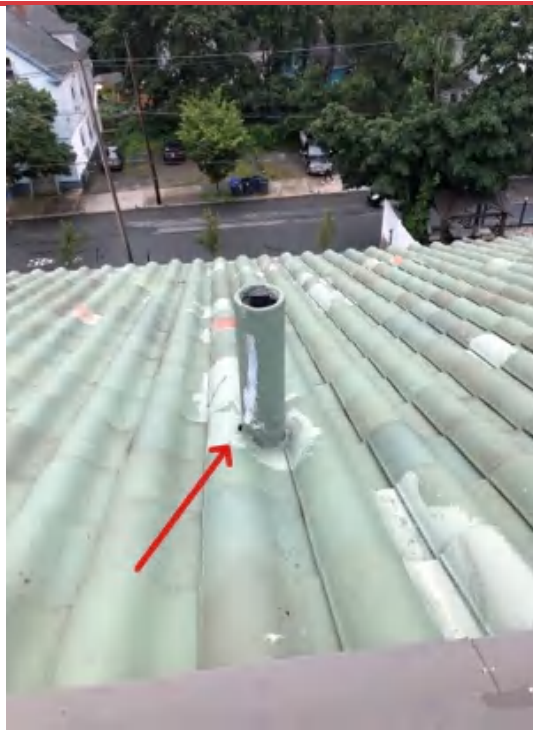
ISSUE 2

View from roof of old cast vent. Notice the holes along side of vent.

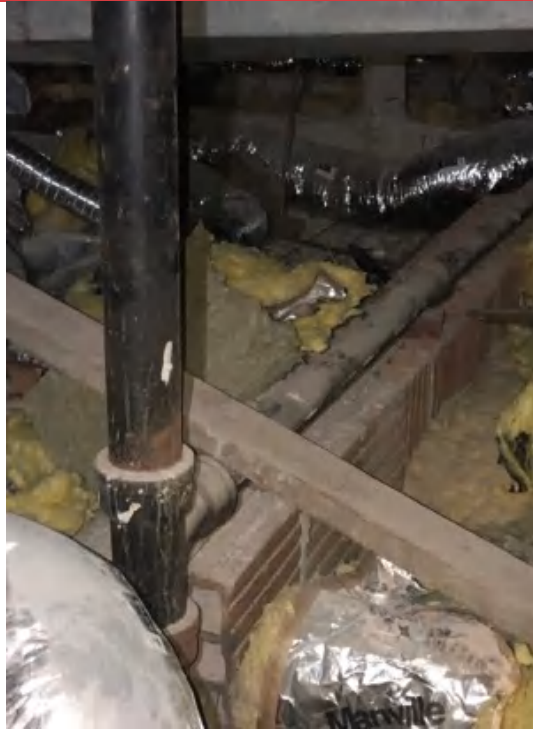
ISSUE 3

Same cast vent from inside

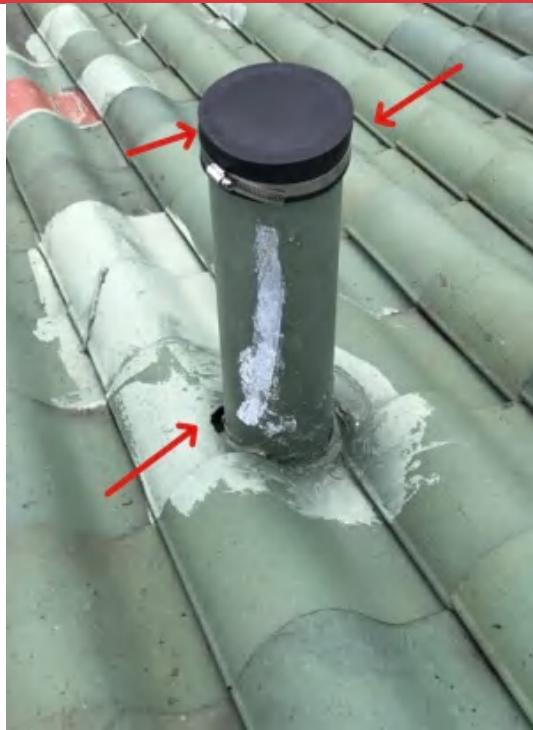
ISSUE 5

Paul Pacheco from Acropolis put a rubber cap on top to stop water from coming in from the pipe. Sides still need to be properly sealed.

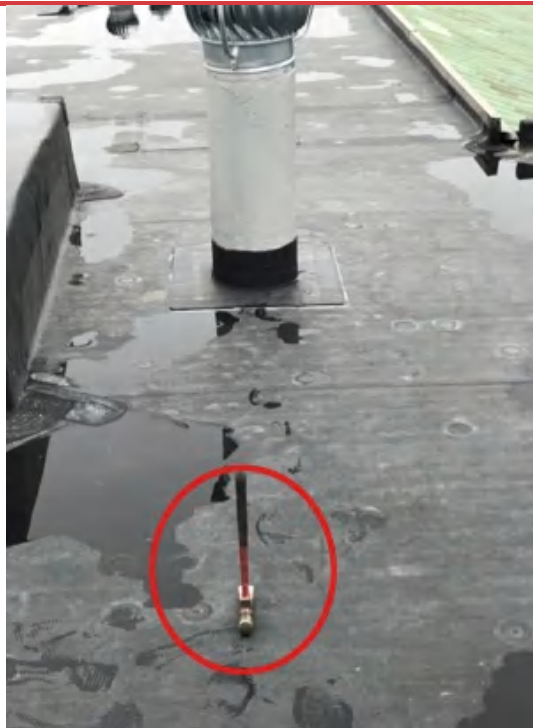
ISSUE 6

View of membrane roof near elevator where there is a constant severe leak every-time it rains. The hammer in photo is just identifying the area leaking.

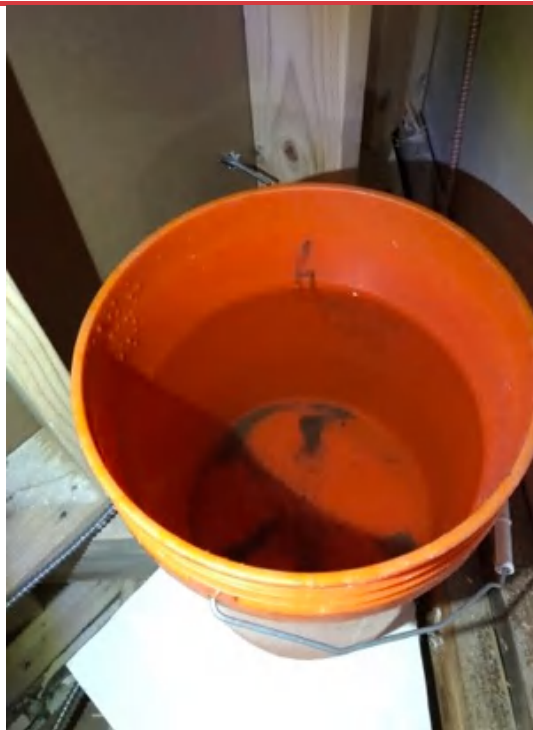
ISSUE 8

It was so bad that we put a bucket to collect the water and rid amount was from one storm.

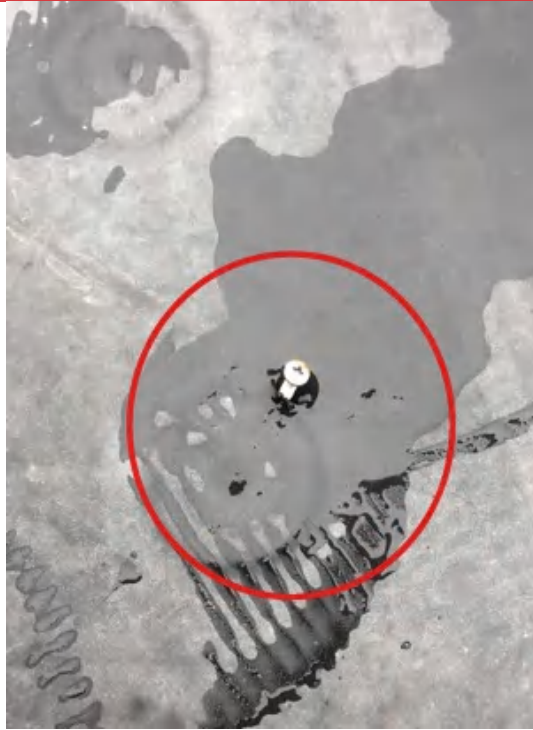
**ISSUE 9**

Upon closer inspection, Paul from Acropolis found a large hole in the exact area. It's so large that he was able to slide a screw in and out of it for purpose of taking a photo. This needs repair. We are unaware of any roof warranties and are not receiving any word back from the developer's side. It's a quick fix.

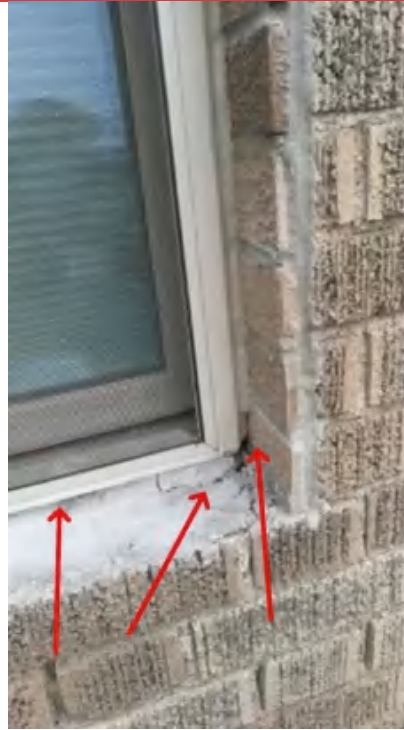
WINDOW

Never sealed properly.

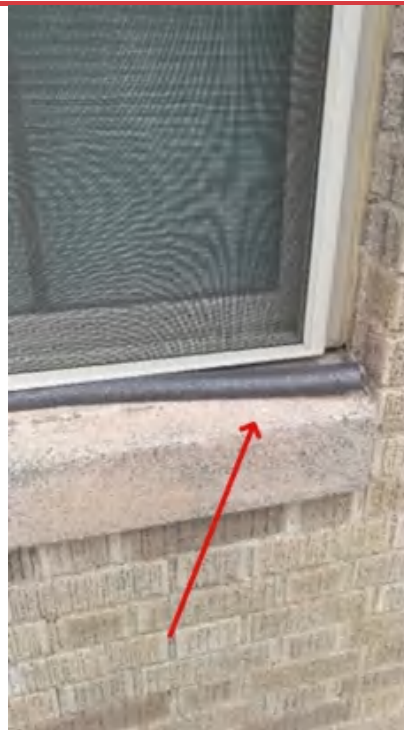
WINDOW AS OF 1/5/21

Many windows have backer rod only and in most cases the backer rod is grossly incorrectly sized or installed poorly. Completely unsealed.

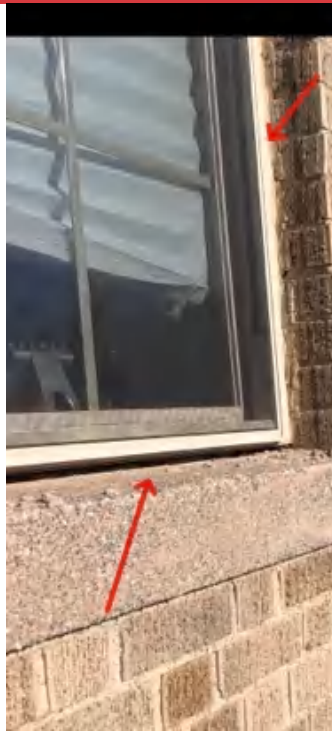
WINDOW AS OF 1/5/21

Wide open gaps.
Unsealed. Bottoms and sides are open to air and water. Poorly I stalled

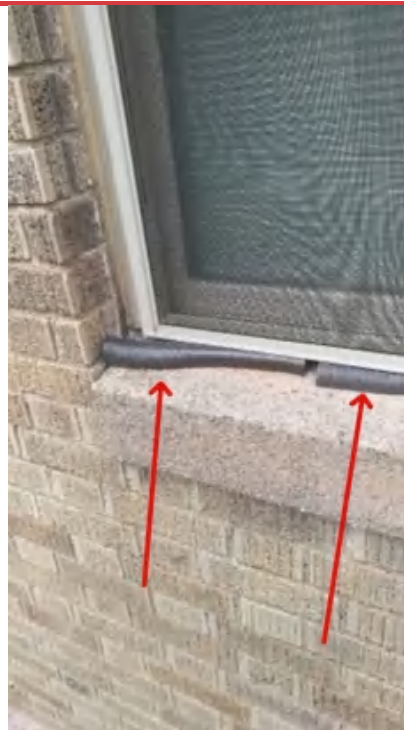
WINDOWS AS OF 1/5/21

Many windows have backer rod only and in most cases the backer rod is grossly incorrectly sized or installed poorly. Completely unsealed.

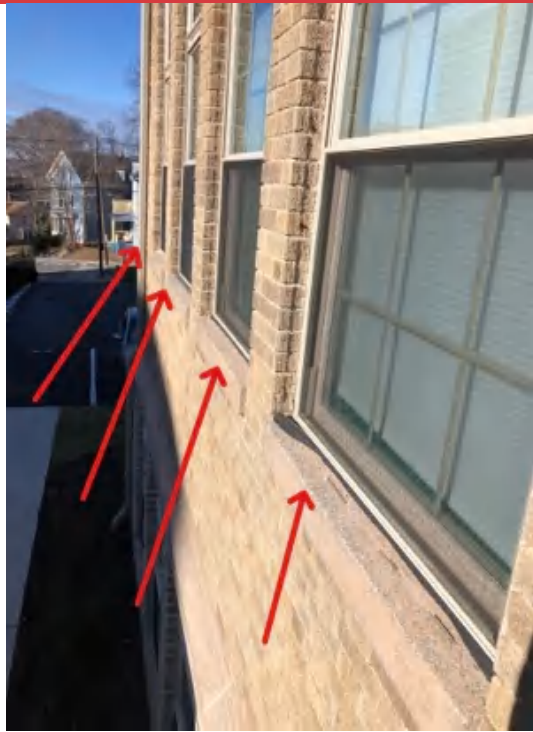
**WINDOWS AS OF
1/5/21**

Many windows have backer rod only and in most cases the backer rod is grossly incorrectly sized or installed poorly. Completely unsealed.

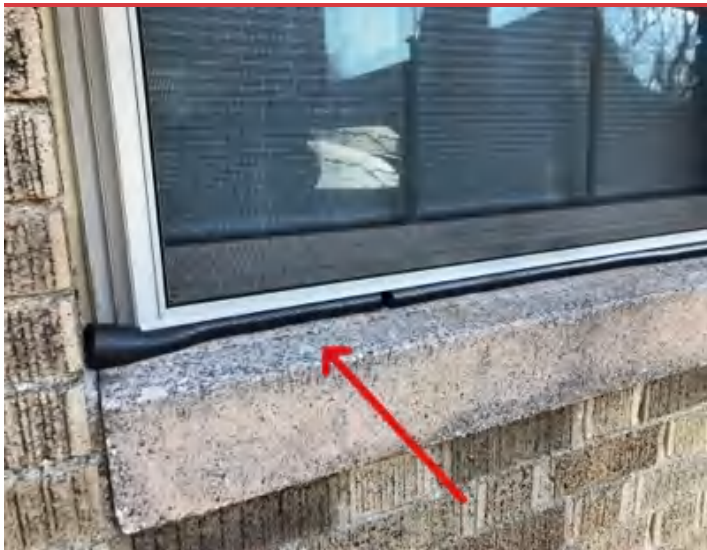
**WINDOWS AS OF
1/5/21**

Many windows have backer rod only and in most cases the backer rod is grossly incorrectly sized or installed poorly. Completely unsealed.

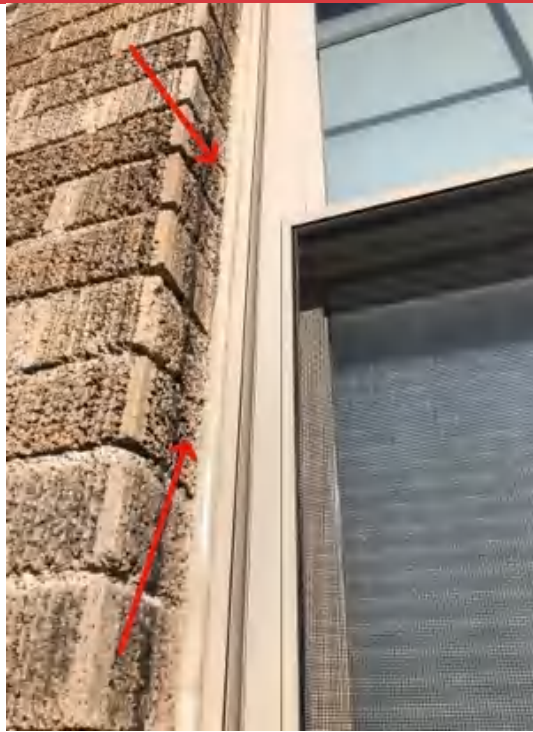
**WINDOW AFTER
PROPERLY SEALING**

This is what it should look like once properly sealed with high quality, polyurethane caulking

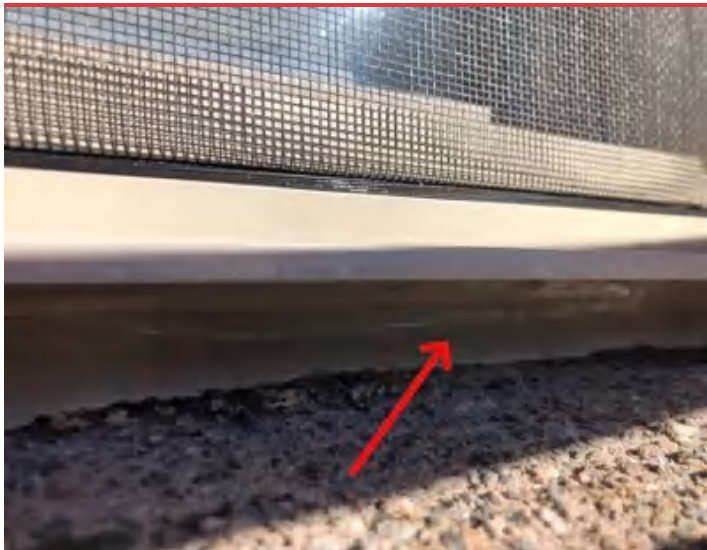
**WINDOW BOTTOM
AFTER PROPERLY
SEALING**

This is what it should look like once properly sealed with high quality, polyurethane caulking

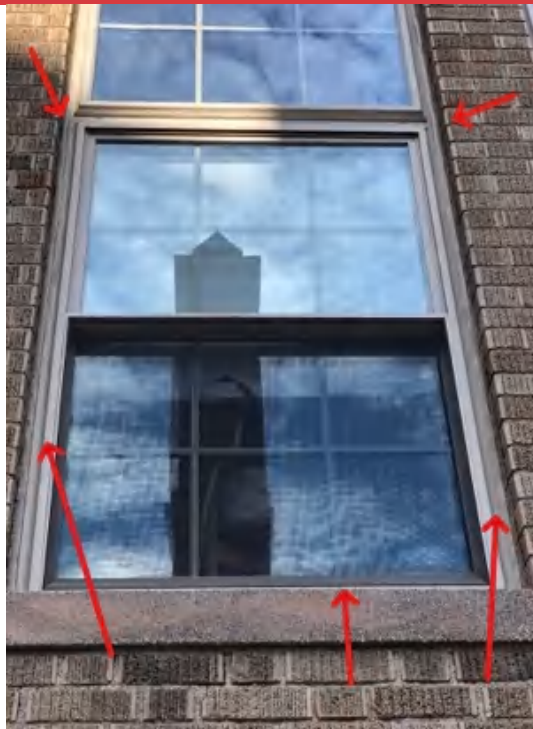
WINDOWS AFTER PROPERLY SEALING

After all joints properly caulked. Backer Rod used where necessary.

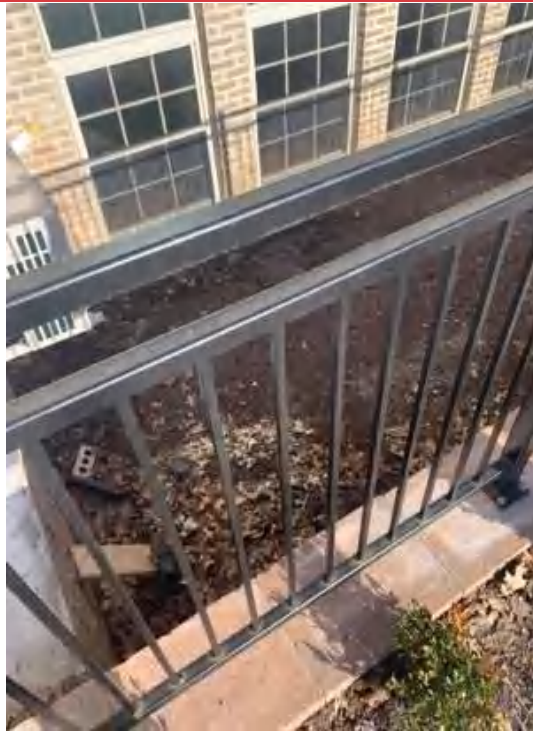
ISSUE 1

Mulch Should be removed from front two lower areas. Add stone in its place for better drainage and less maintenance.

1/2 done.

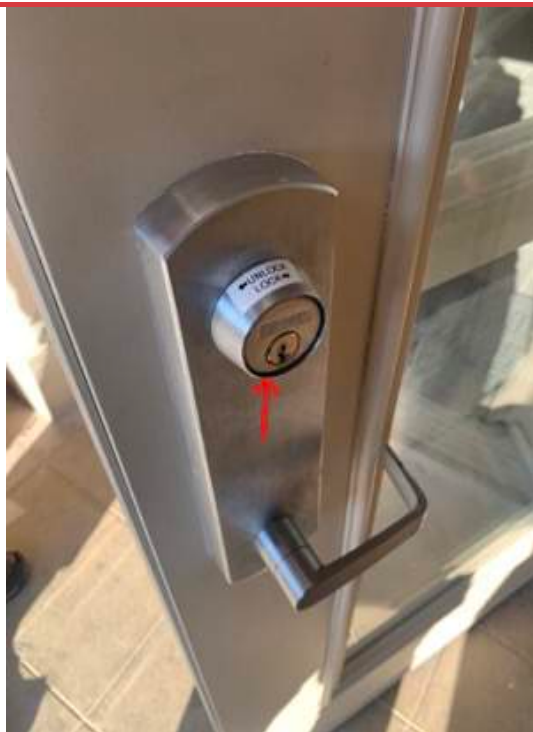
ISSUE 2

All exterior locksets should not be allowed to stay unlocked. Should be self locking.

City Lock will handle and rekey all to match front door.

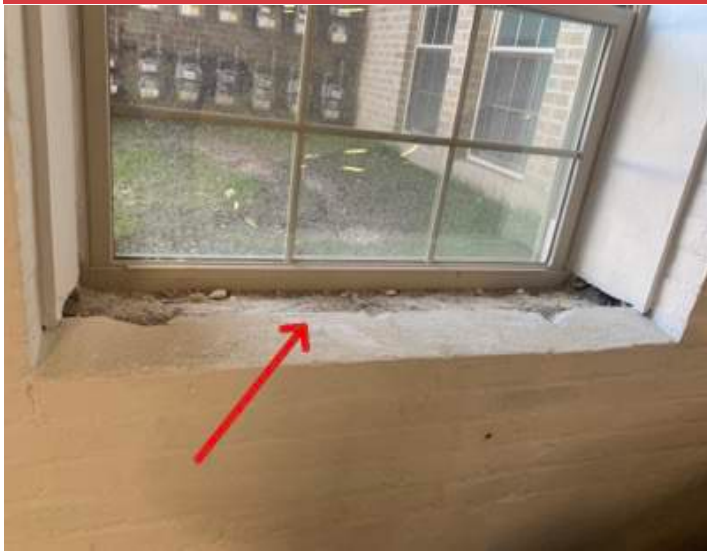
ISSUE 3

Garage interior window sills are all unfinished.

Not done. Ams could do.
Not major.

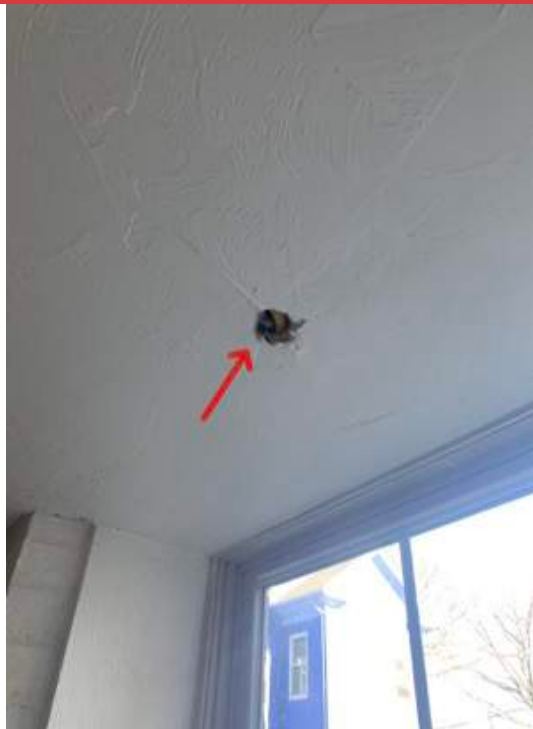
ISSUE 4

Penetrations and holes in garage ceilings should be filled and painted.

Done

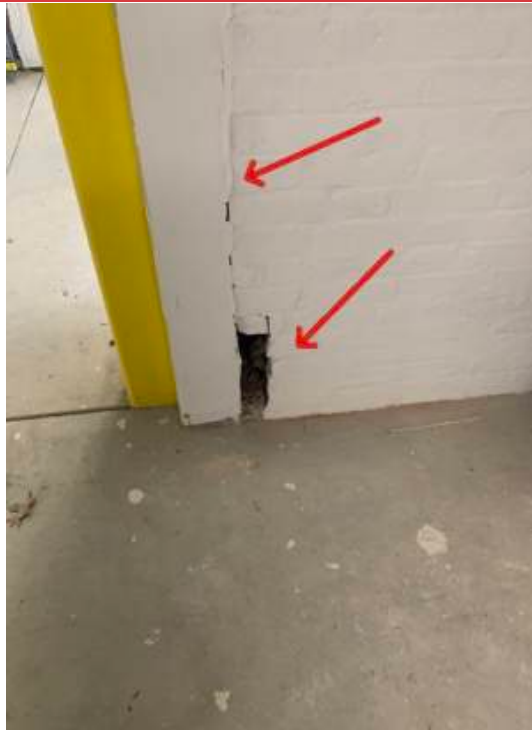
ISSUE 5

Missing bricks and cracks in garage wall. Should be filled and painted.

Done

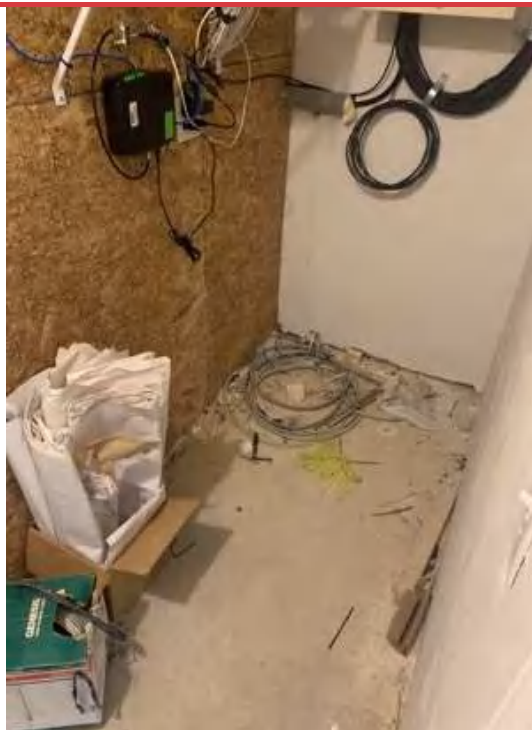
ISSUE 6

All storage areas and electrical rooms need to be cleaned out and emptied. All floors in these rooms need to be cleaned thoroughly.

Done

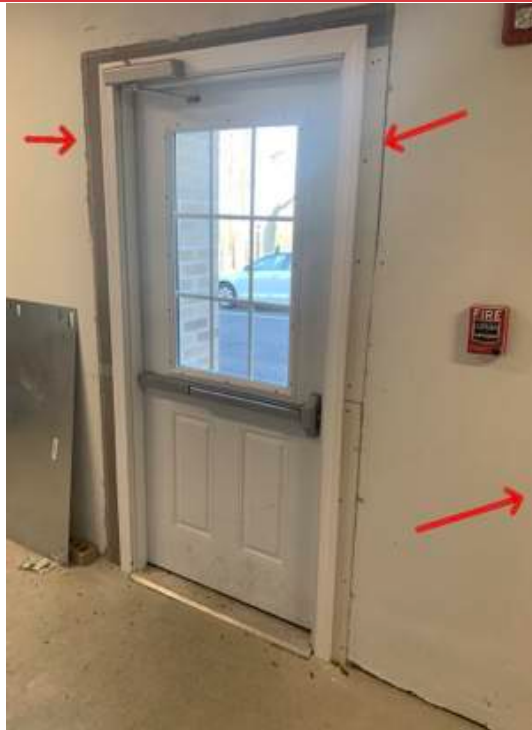
ISSUE 7

Rear exit door and garage door have incomplete Sheetrock, tape and compound work to do. Then needs finish painting.

Done

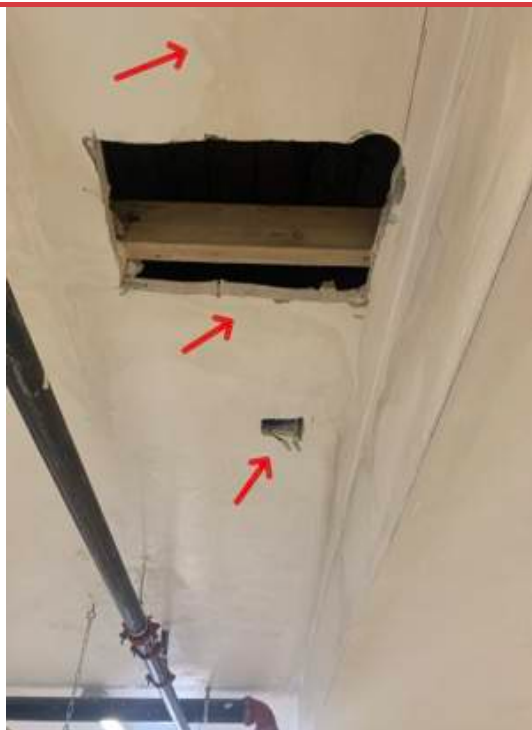
ISSUE 8

Holes and water stains on garage ceiling by exit area need to be repaired and repainted.

Done

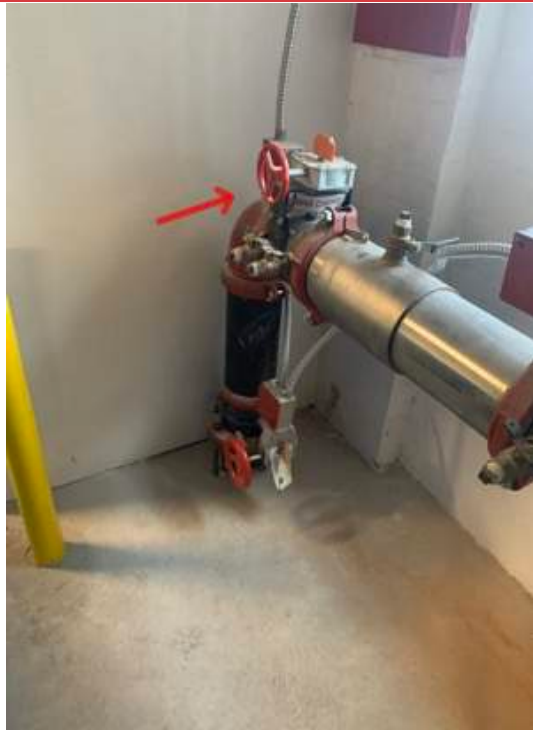
ISSUE 9

Check with contracted Sprinkler Inspector to see if these valves require locks and chains to prevent tampering.

Not required. Remove from list.

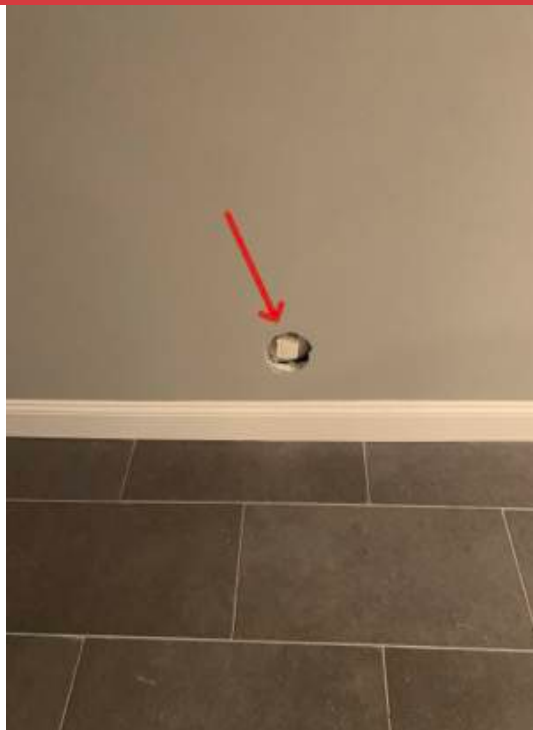
ISSUE 10

Cover clean out with an access panel like others in building.

Done.

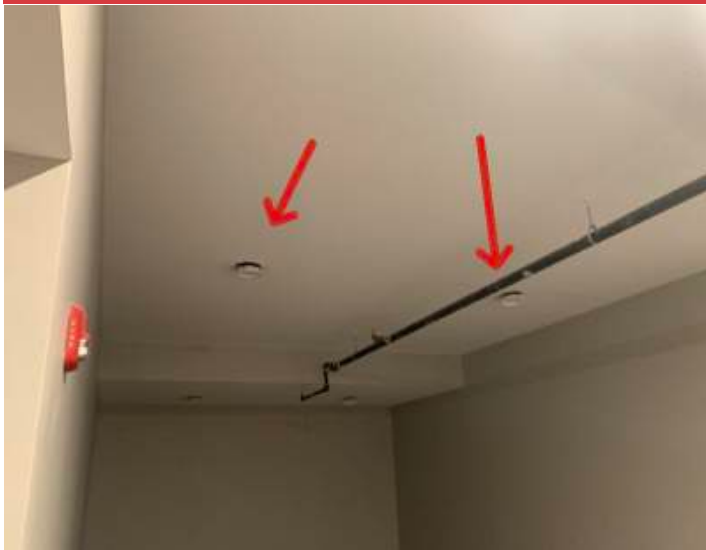
ISSUE 11

All recess lights in area outside garage entrance in first floor are hanging down. Need to be pushed up in place.

Done.

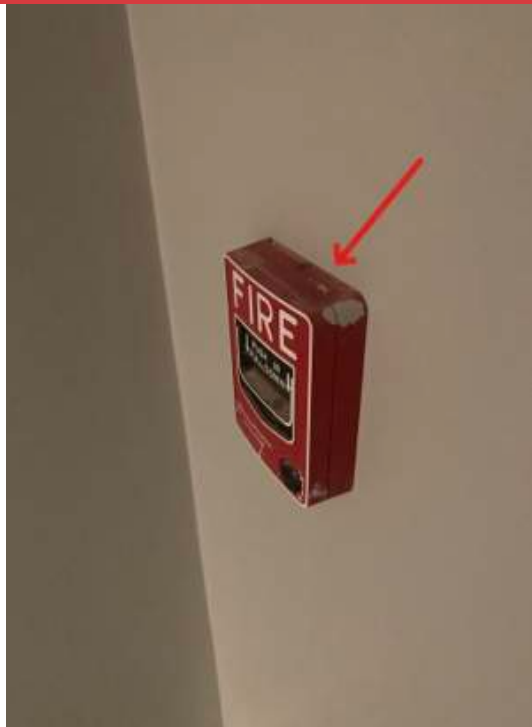
ISSUE 12

There is paint on all fire alarm devices. Need to be cleaned. Could cause fire code issues.

Not done. AMS could easily do.

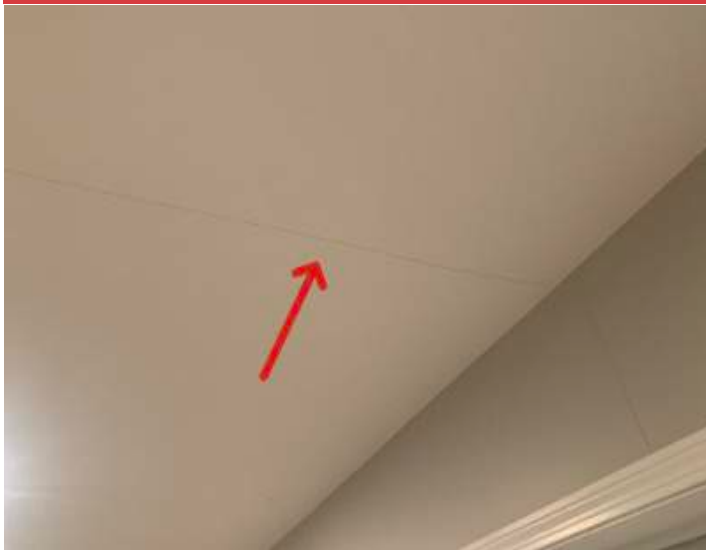
ISSUE 13

There are several stress cracks in ceilings on first floor hallway. Need taping, compound and paint.

Seemed to be done.

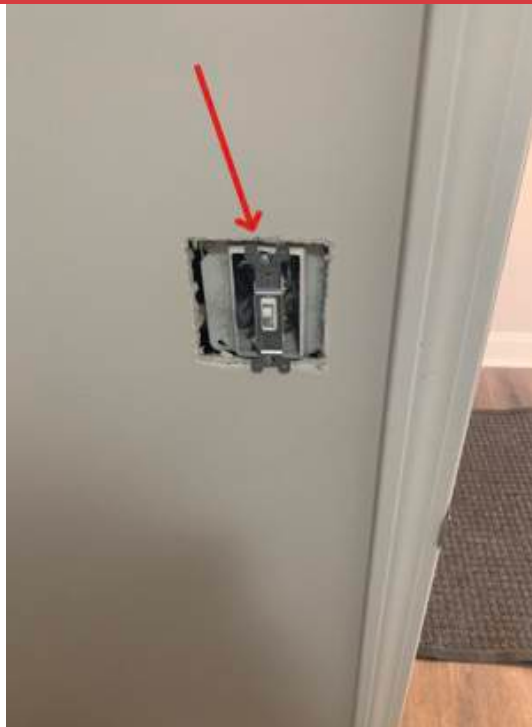
ISSUE 14

Community room bathroom. Proper light switch cover needs to be installed to prevent someone from being shocked.

Wall is repaired. Needs switch cover that AMS will add.

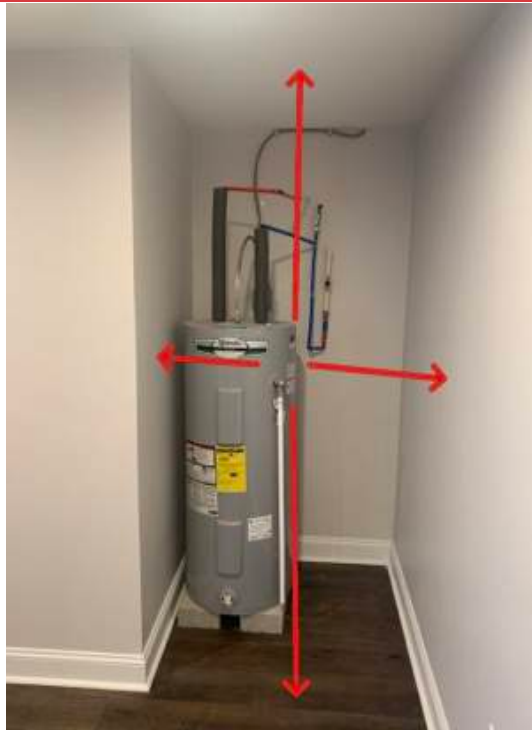
ISSUE 15

Build a closet to conceal
Community room water
heater.

Not done. Not major.
AMS could easily build.

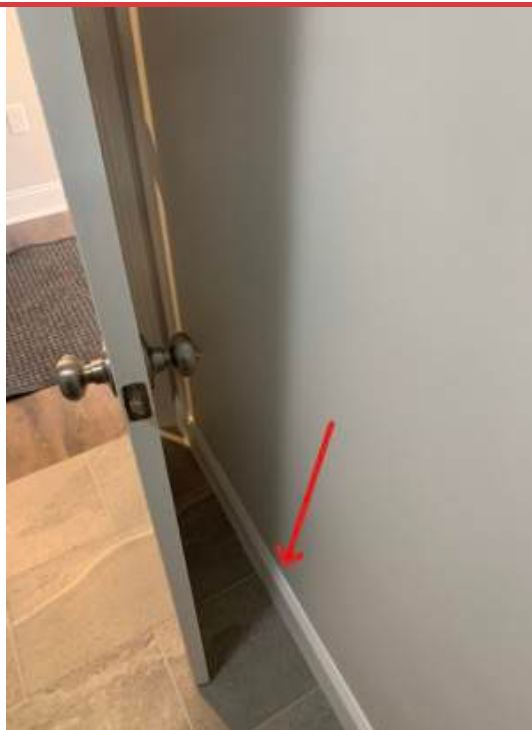
ISSUE 16

Bathroom door needs a
doorstop in community
room. Wall will get
damaged

Done

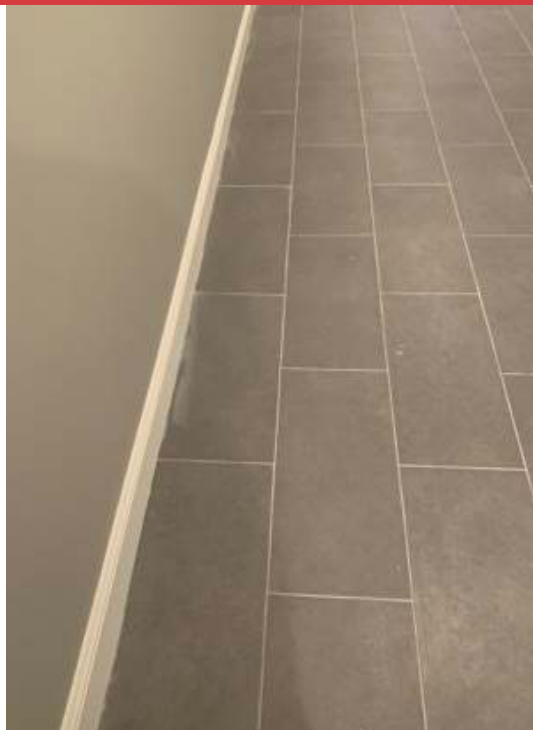
ISSUE 18

There is paint and grout on the tile throughout the building. It needs to be professionally scrubbed clean.

Done. All scrubbed and resealed.

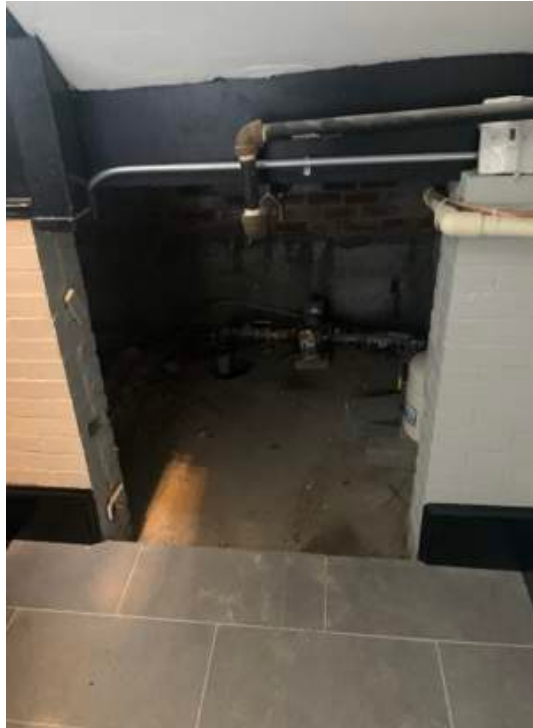
ISSUE 19

Close off the water main access underneath Locust Street entrance by making a simple panel door.

Not done but AMS could easily do

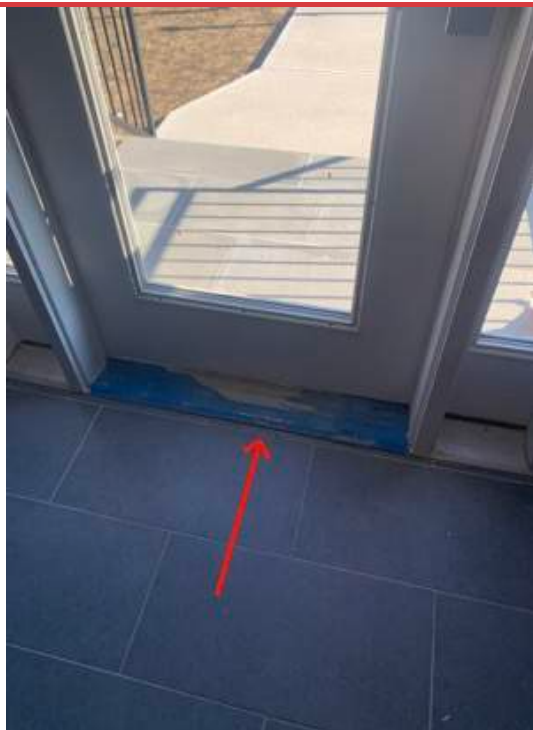
ISSUE 20

Remove blue painters tape throughout Locust Street side stairwell and touch up paint where necessary

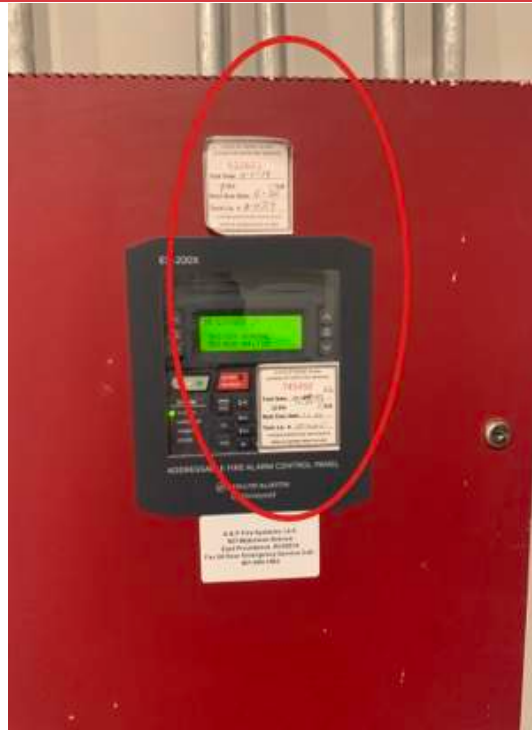
ISSUE 23

Fire panel needs to be inspected quarterly.

We took care of.

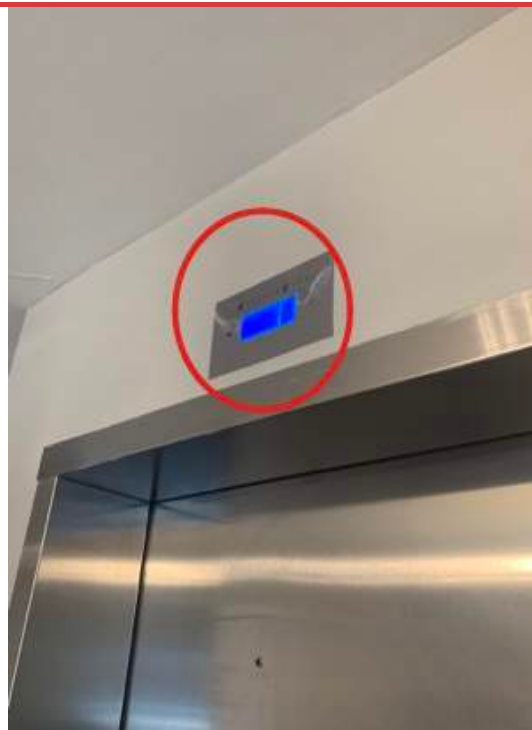
ISSUE 24

Elevator top panel is loose and plastic needs to be removed.

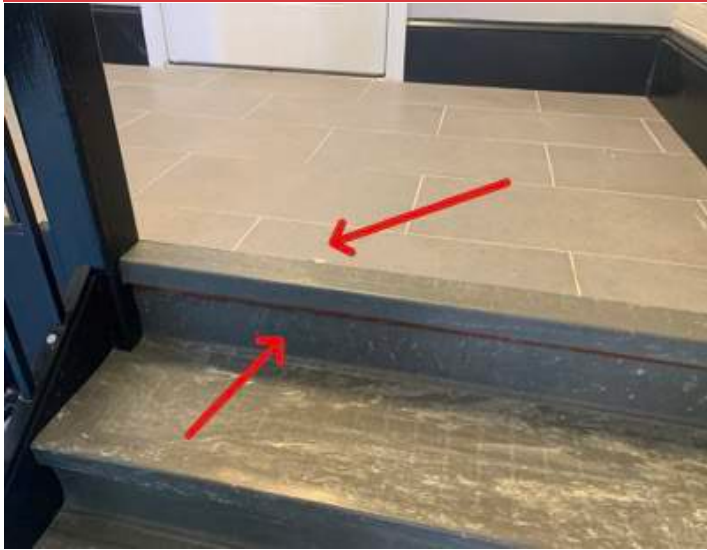
ISSUE 27

Old stair nose needs to be painted black like the others and repair the chipped tile on the church side stairwell

Acceptably repaired
