Chapel Hill East Condominium
Documents Relating to Construction Issues

Current 06/07/2023

CONDITION ASSESSMENT REPORT

Building Enclosure Science, LLC (BES) was commissioned by Acropolis Management Services (Acropolis) to perform a condition assessment of the building envelope at 7 Mount Hope Avenue, Providence, RI.

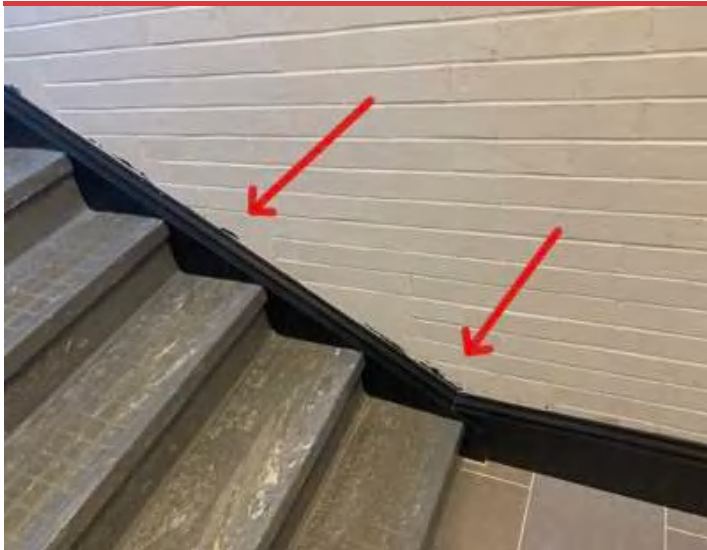
ISSUE 28

There is black paint from the stair risers. The walls need to be touched up because of it

Done

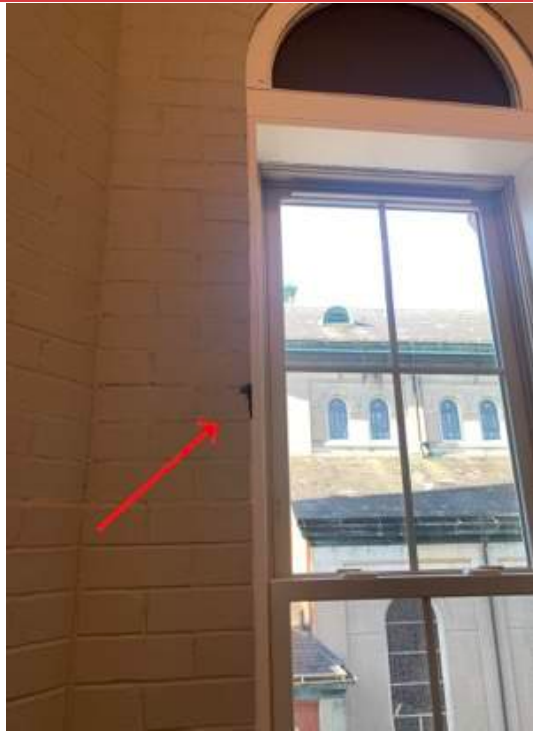
ISSUE 29

There is a hole on the side of the church side window that needs to be filled and sealed.

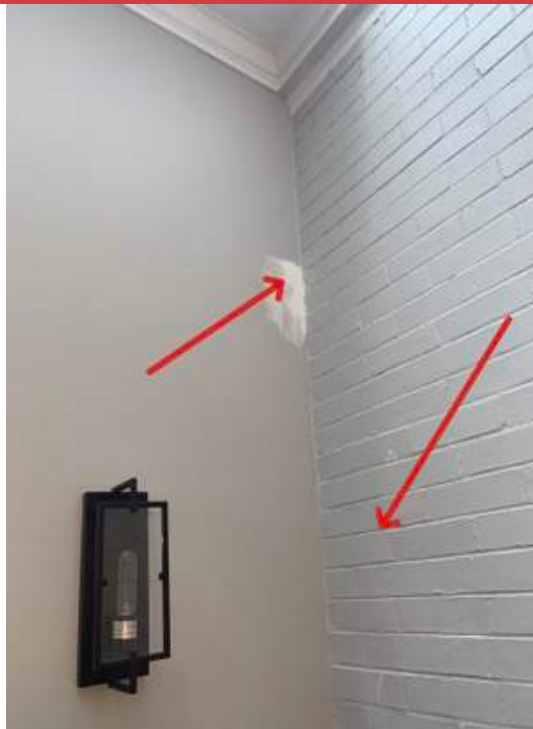
ISSUE 32

Finish wall repairs and clean dry wall dust throughout stairwells.

Done

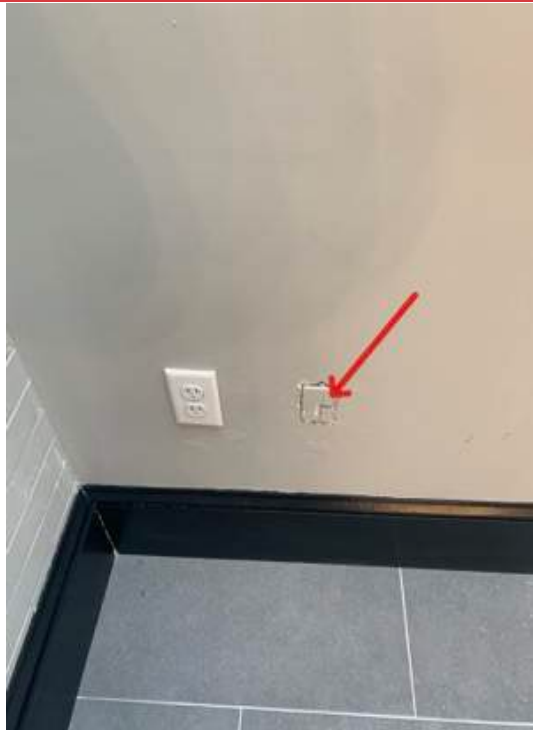
ISSUE 33

More wall repairs. See 32.

Done

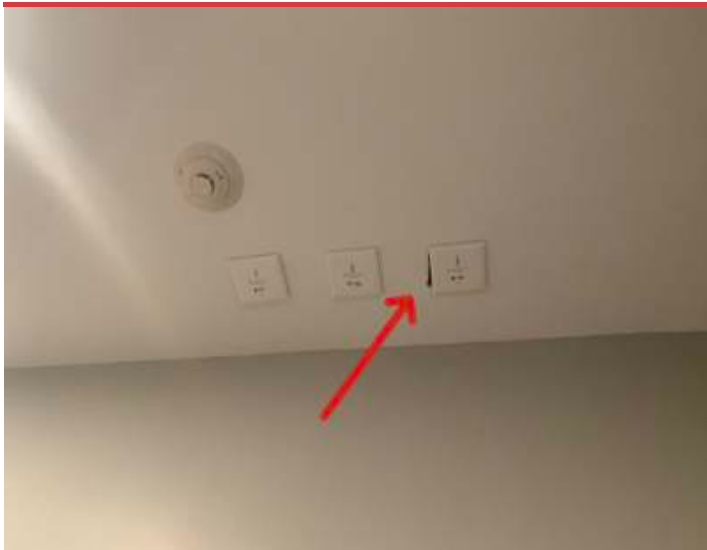
ISSUE 36

Drywall repair and painting needed next to fire alarm electrical devices.

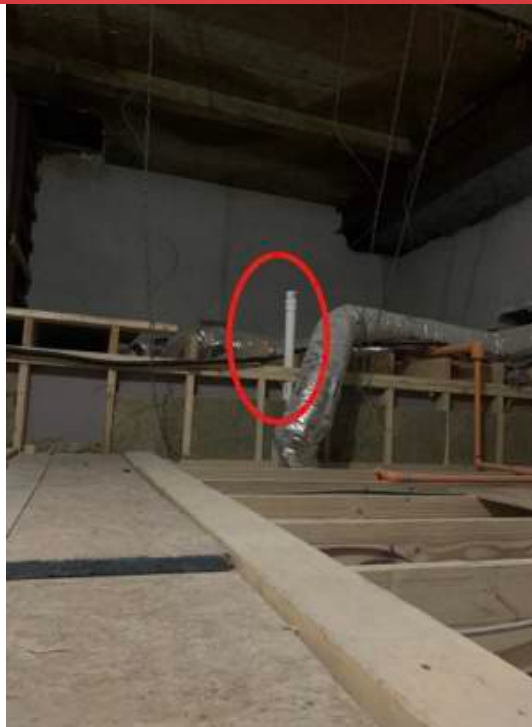
ISSUE 42

There is a drain vent terminating in the roof access crawl space. This needs to vent out the roof properly.

Still as pictured

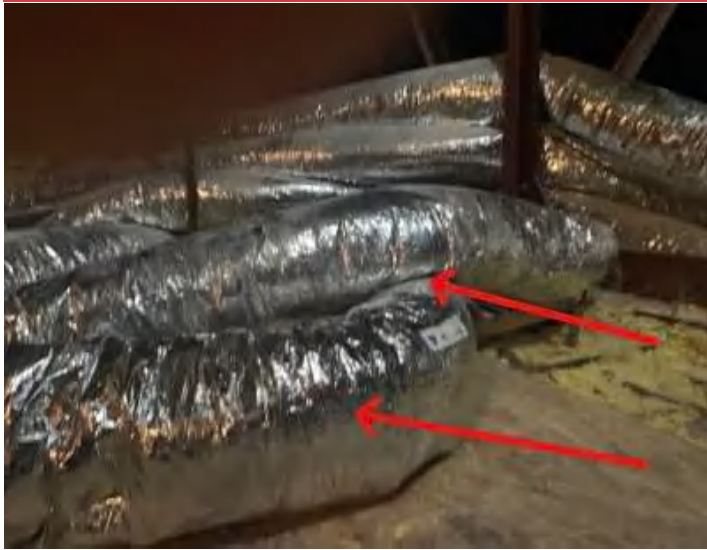
ISSUE 43

In access hatch outside 307, there is debris and spare duct work left. Area needs to be cleared of all non essential items.

Still there

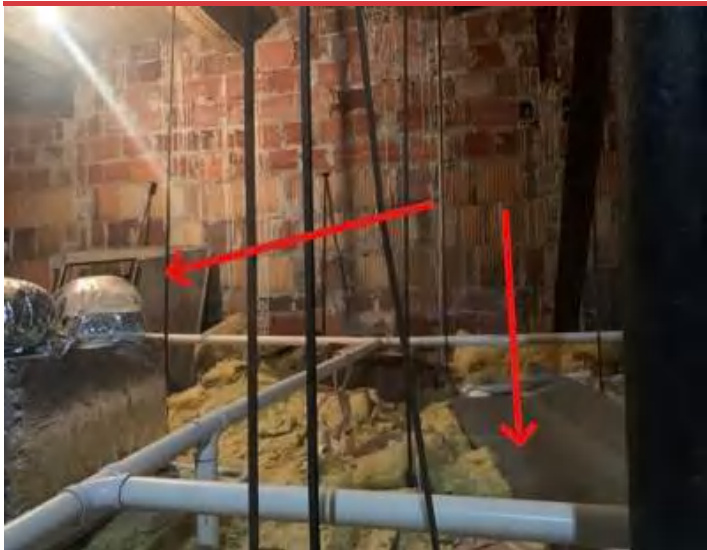
ISSUE 44

See 42

Still as pictured

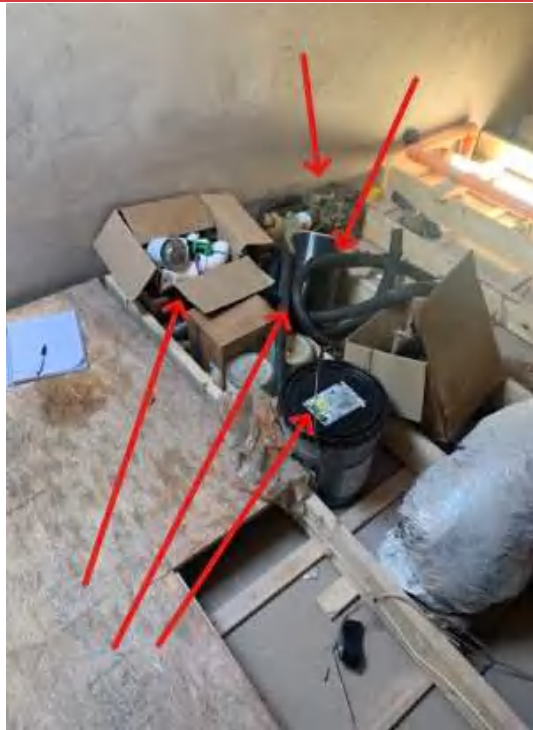
ISSUE 45

There are building materials and trash left in roof access crawl space

Even more there now.
Including old hvac pads

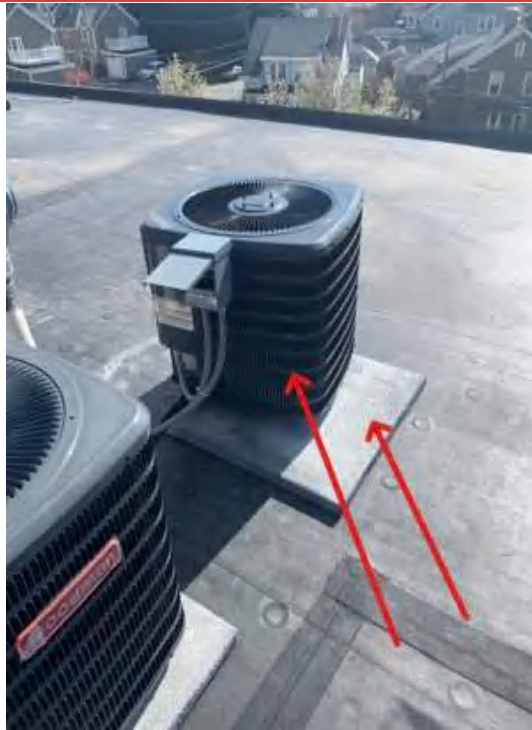
**ISSUE 46**

Very dangerous situation in which the hvac pads are too light and the units and the pads are not anchored. Wind has moved the units. Several are off the pads causing the piping to get twisted and leak gas as well as causing dangerous electrical situations.

These pads have been replaced. Pads are not anchored to roof but units are now anchored to pads. May be acceptable.

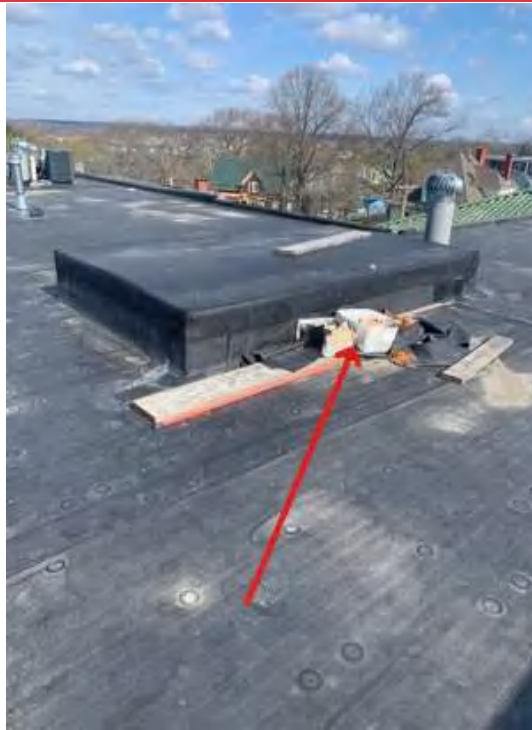
ISSUE 47

Unfinished area of roof that has debris surrounding it. This is right above an apparent leak near elevator on 3rd floor.

Looks to be complete. Still lots of debris on roof.

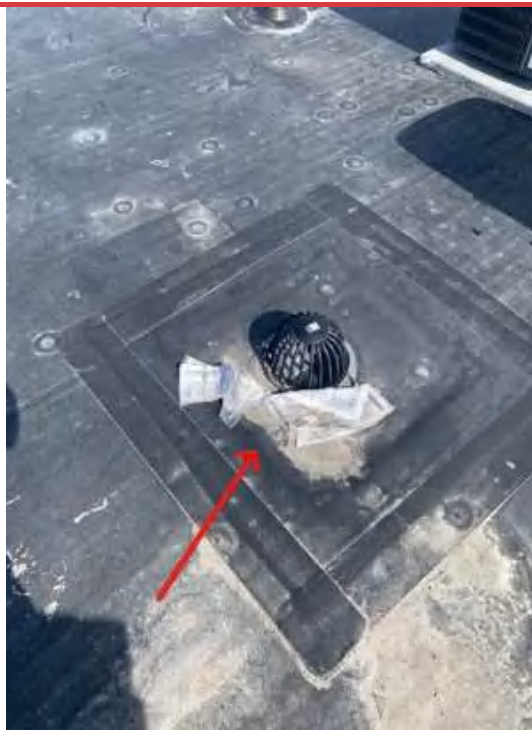
ISSUE 48

Manuals from HVAC units and other debris are clogging roof drains.

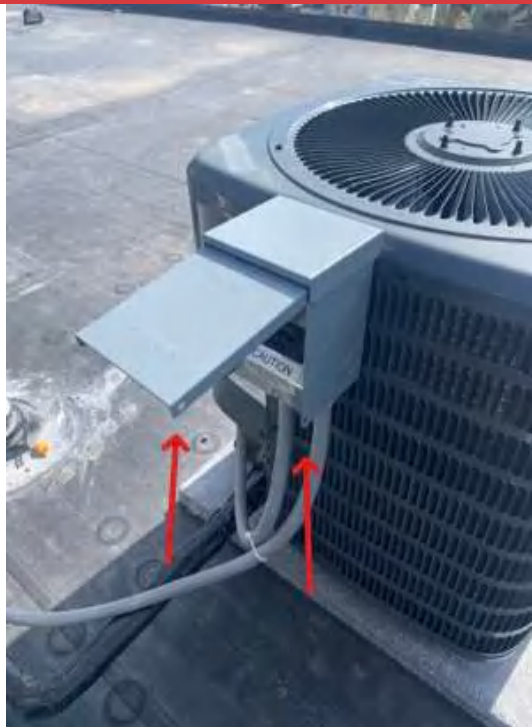
ISSUE 51

Pads are too light and not anchored. Hvac units are not anchored. Has blown over causing extremely dangerous problem. Unit will not function.

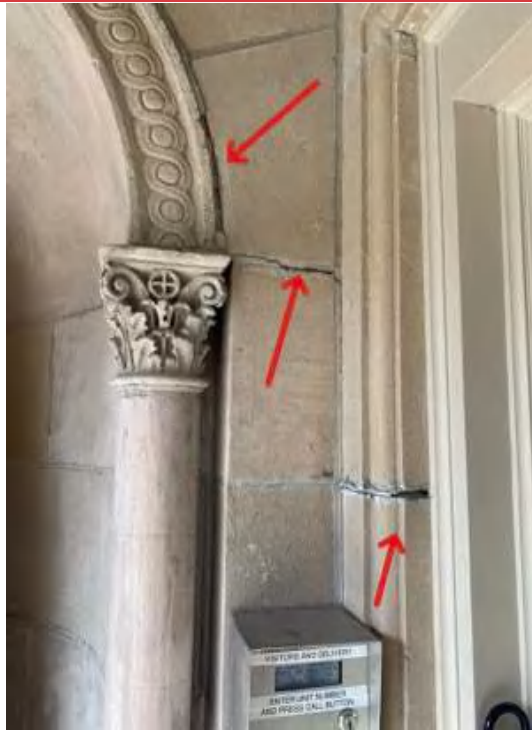
ISSUE 55

Masonry repointing needed near entrance way

Bay state preparing master masonry plan

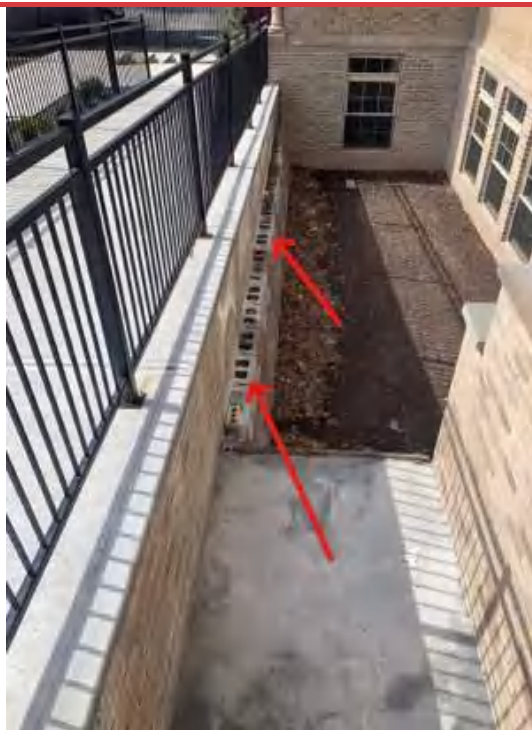
ISSUE 56

Retaining wall is missing cap. Needs attention ASAP. Also remove mulch add stone for drainage.

Done.

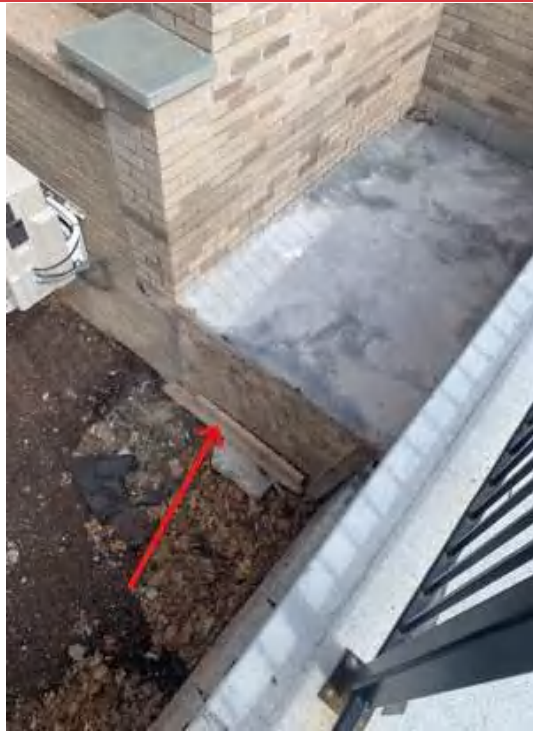
ISSUE 57

Remove plywood forms on concrete

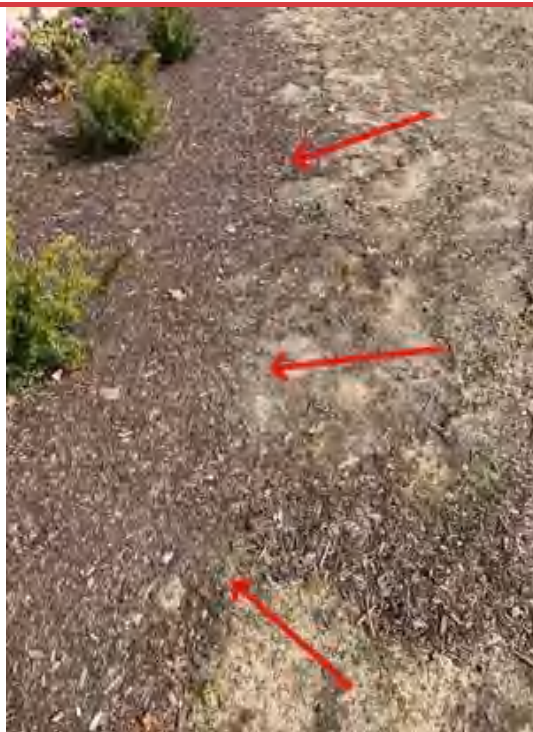
ISSUE 60

See 59 regarding lawn areas. All beds need to be edged to define and hold mulch in place.

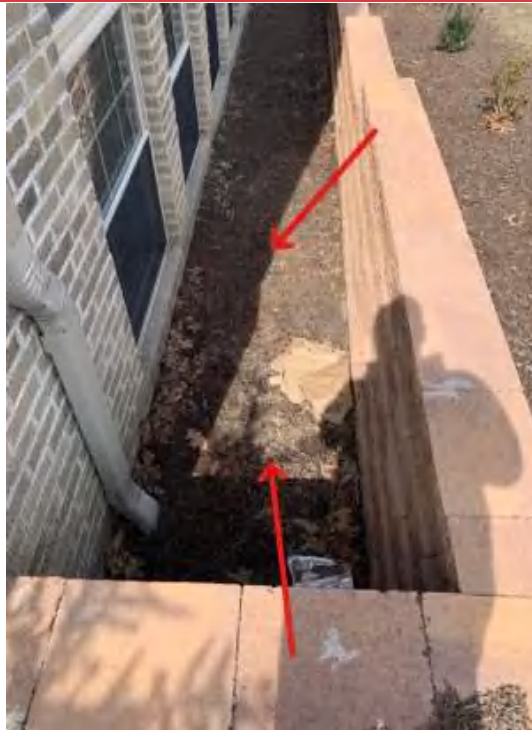
ISSUE 61

Mulch needs to be removed and add gravel in its place to improve drainage.

Done.

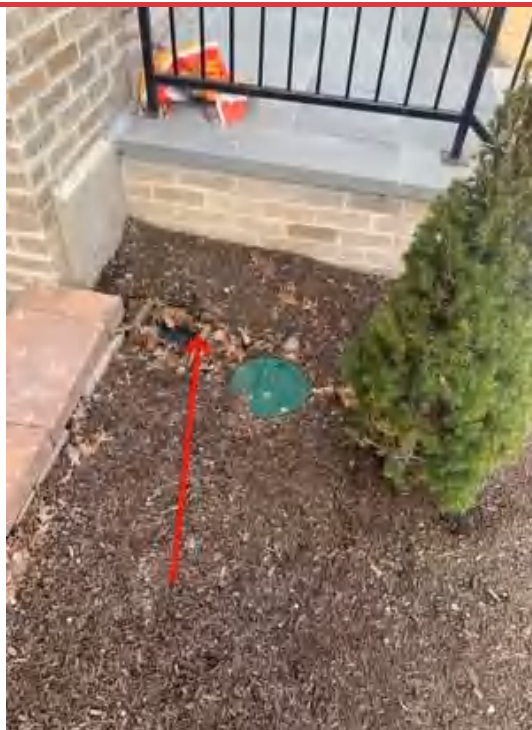
ISSUE 62

Irrigation is unfinished. Needs to be completed and then inspected by a third party vendor to assure functionality.

Done.

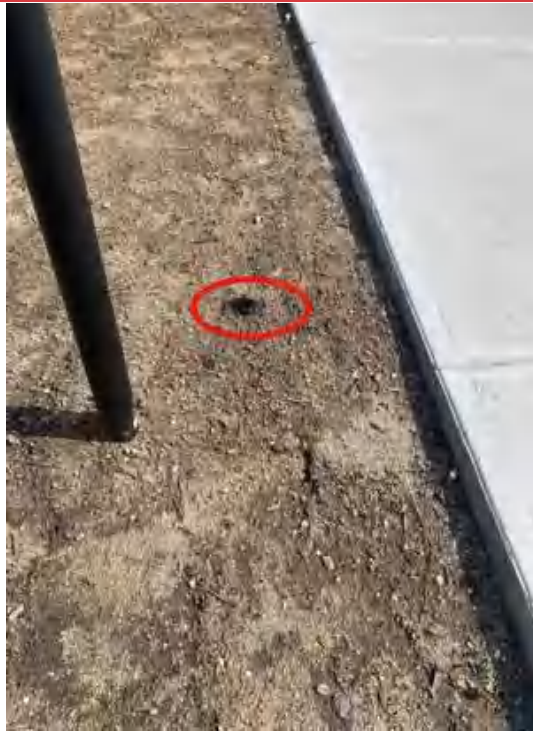
ISSUE 63

All Sprinkler heads need to be set at grade

Done.

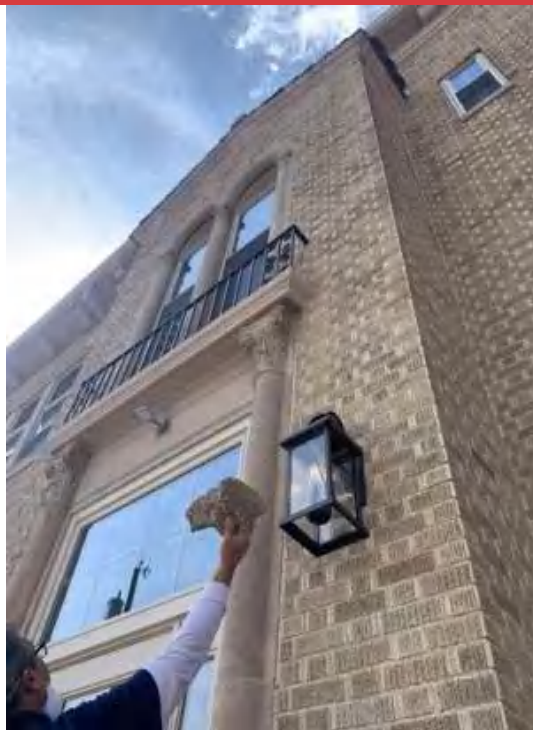
ISSUE 64

Masonry detail needs to be repaired. The original piece was found broken on the ground

Gone.

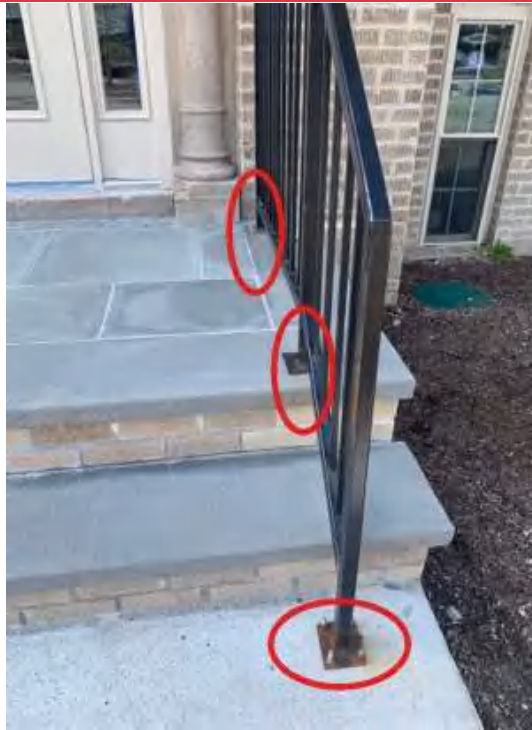
ISSUE 65

Railing system needs to be bolted to the ground and bolts need to be cut with a grinder so that they are not protruding. All needs to be painted with rust preventative type product.

Not done.

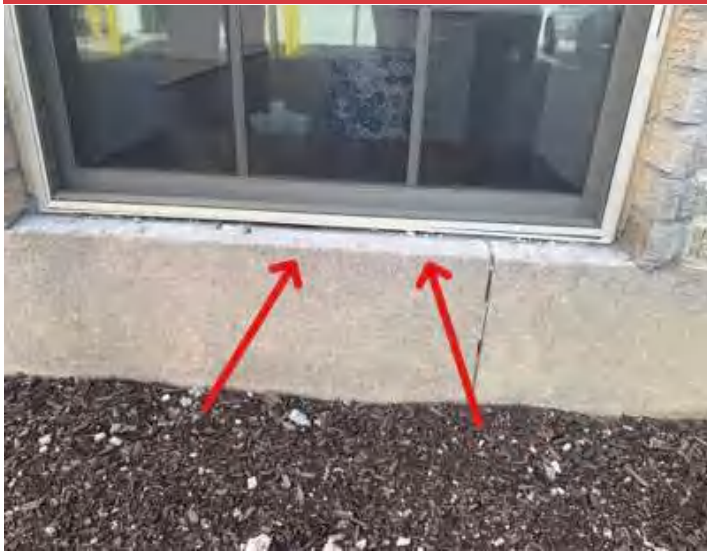
ISSUE 67

Exterior windows need to be sufficiently sealed. Many of the sills are wide open.

Not done. Major item

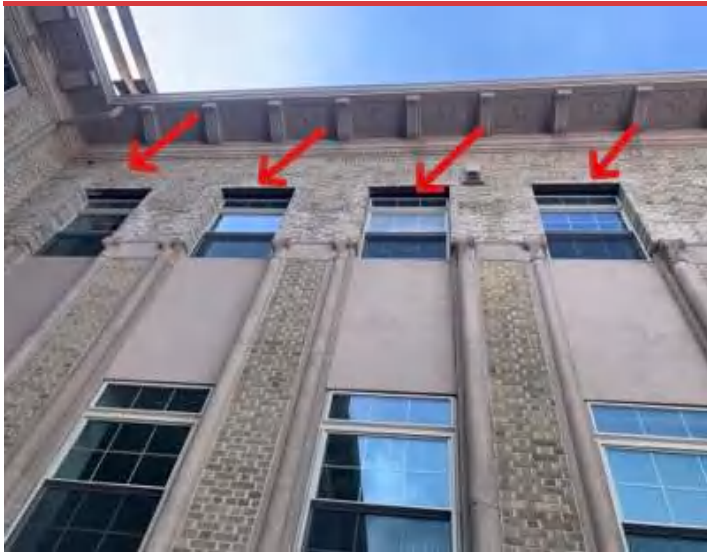
ISSUE 68

The tops of all of the windows are open and need to be properly sealed to complete installation.

Done. May be acceptable. However the window installation as a whole is very questionable! See sides of windows with slivers of brick cut and mortared in.

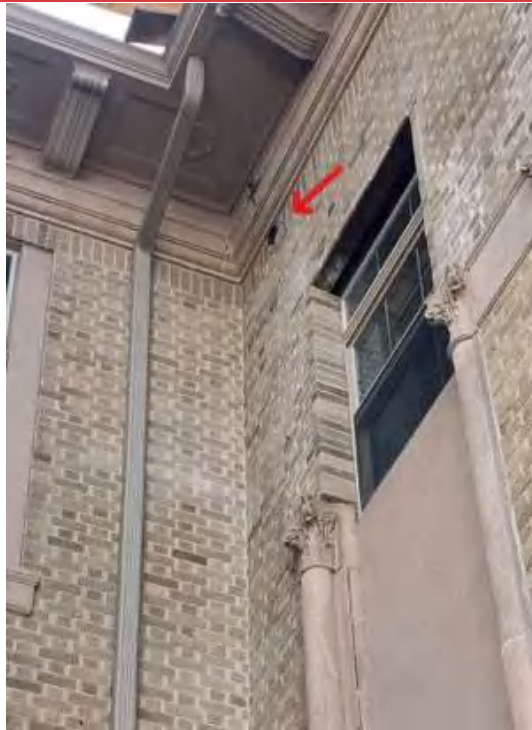
ISSUE 69

Open vent on exterior of building on the rear with birds nesting in the opening. This needs to be properly sealed.

Not done.

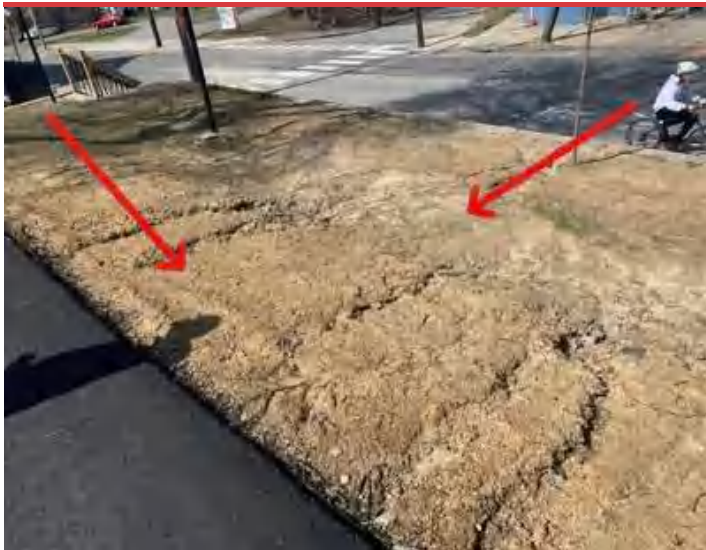
ISSUE 70

Serious erosion and grading issues on the rear of the property along camp street. This needs to be regraded properly and seeded.

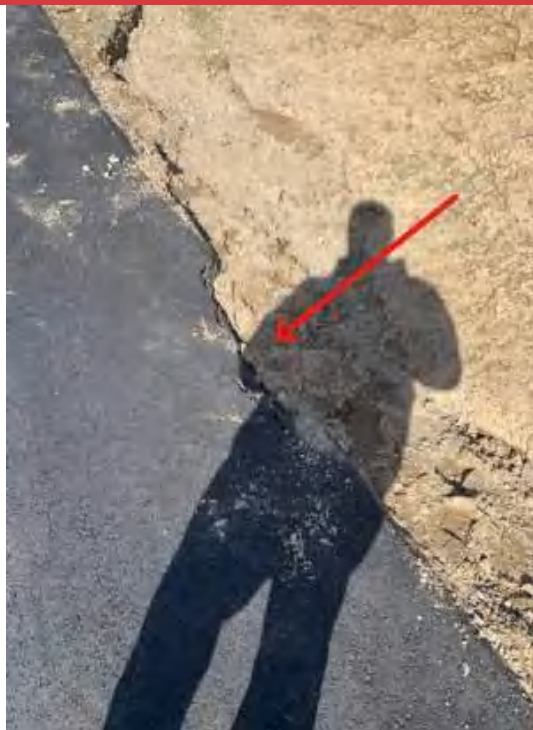
ISSUE 72

See 71. Asphalt needs to be repaired due to erosion and poor grading

Not done

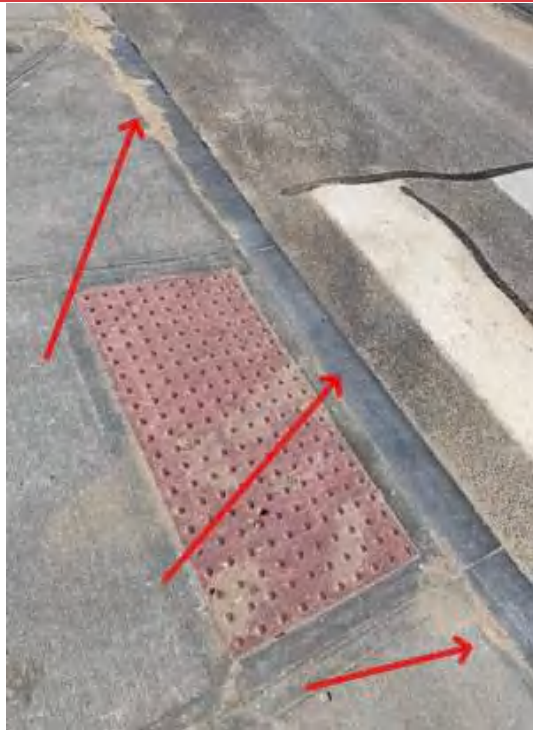
ISSUE 73

Appropriate curb cut needs to occur so that a proper entrance is created for the parking lot. This is incomplete

Not done

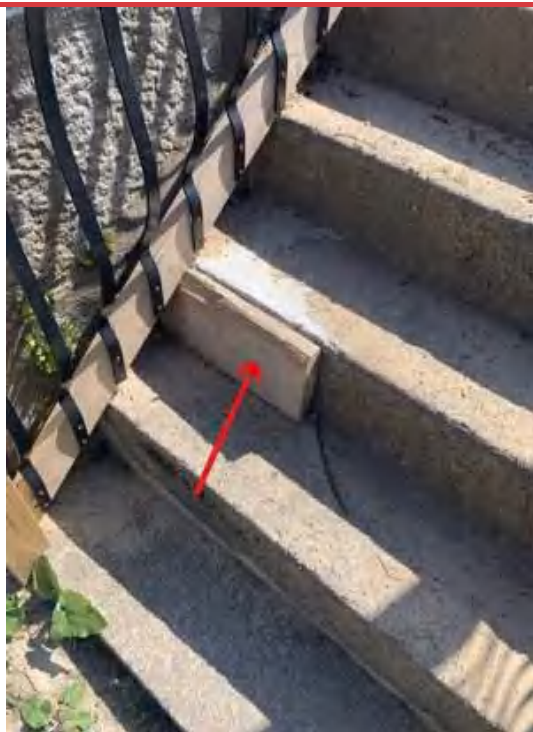
ISSUE 74

Forms need to be removed.

Done

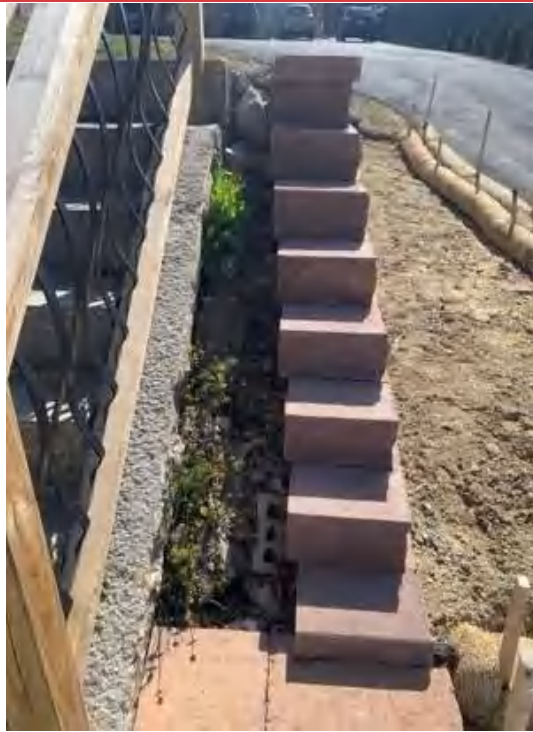
ISSUE 75

Fill and topsoil behind retaining wall needs to be completed.

Not done

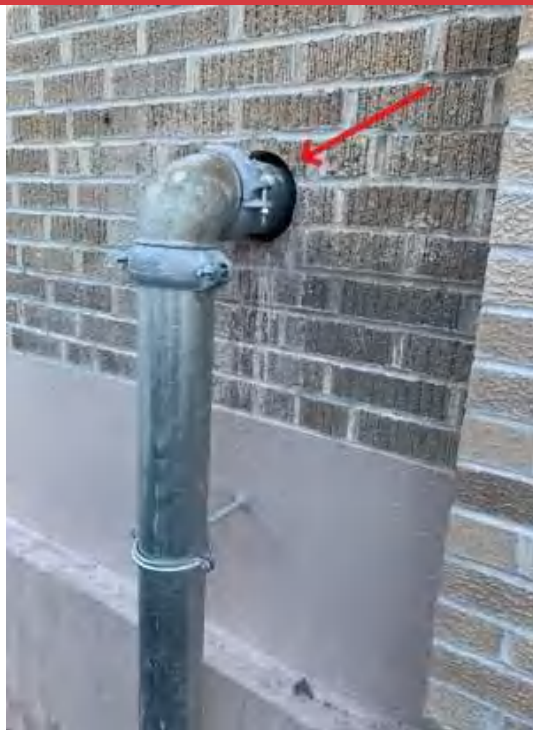
ISSUE 76

Main sprinkler line going into the garage needs to be sealed properly.

Done

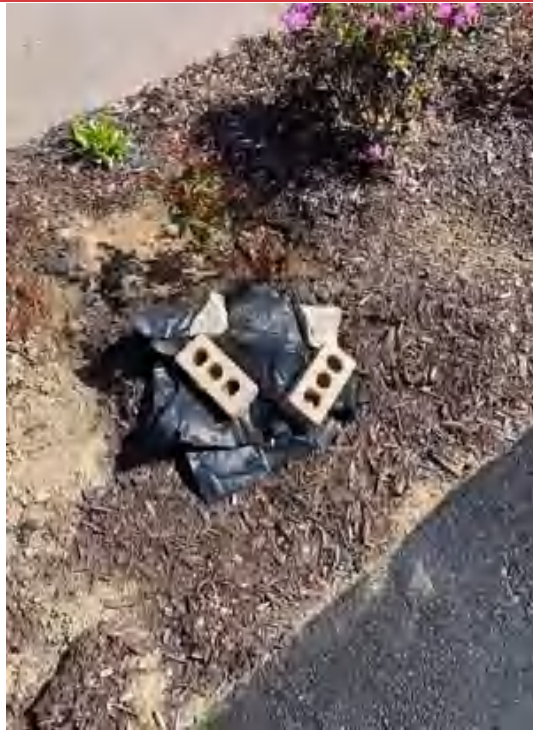
ISSUE 77

Identify what this drain line connects to and then properly it with a clean out.

Not done.

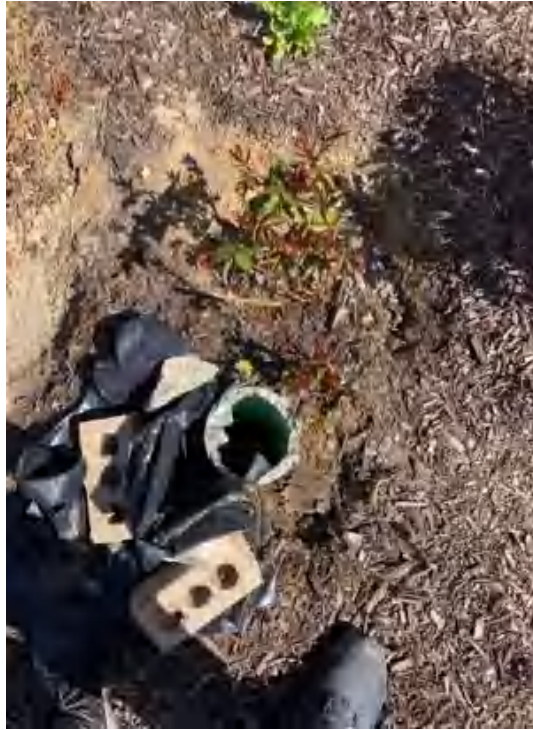
ISSUE 78

See 77.

Not pictured, but extremely important is the fact that there have been numerous back ups and Woods Rooter service Has on two occasions at least that we know of snake the line and hit tree roots which is indicative of a major problem. The main sewer pipe needs to be inspected with a camera system and most likely replaced.

Not done

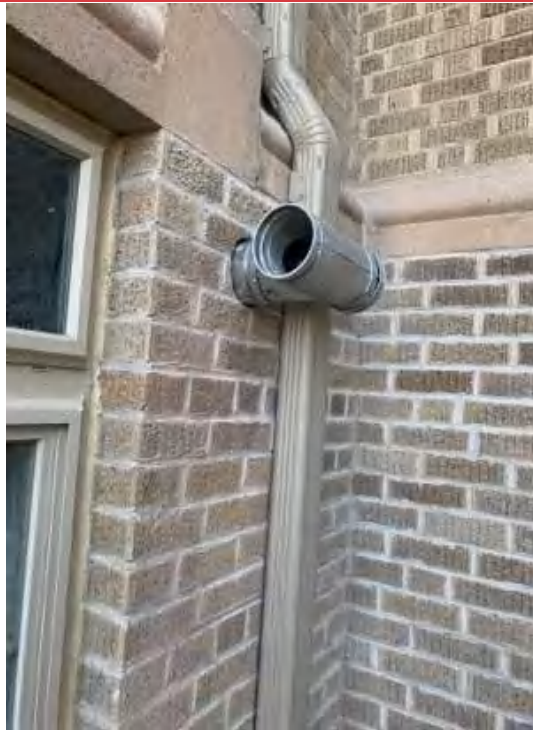
ISSUE 79

Properly cover these vents to prevent animal infestation

Not done

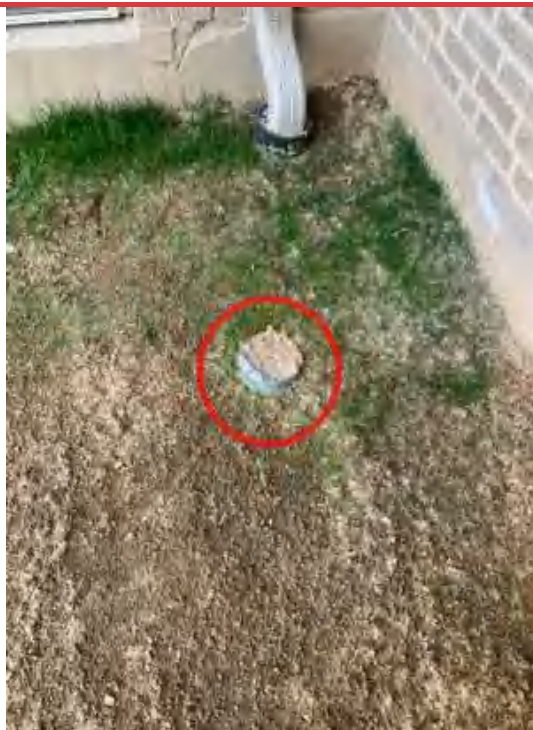
ISSUE 80

Identify what this drain is for and install a cleanout and cap. If this is for the downspout, then it needs to be properly installed and connected.

Not done

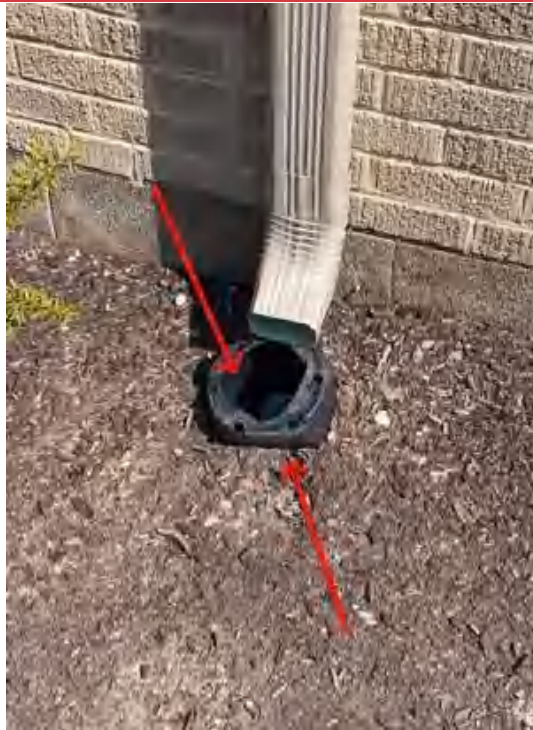
ISSUE 81

This is incomplete and needs to be repaired. The downspout is not lining up with the drain pipe and the drain pipe is broken below ground level

Done

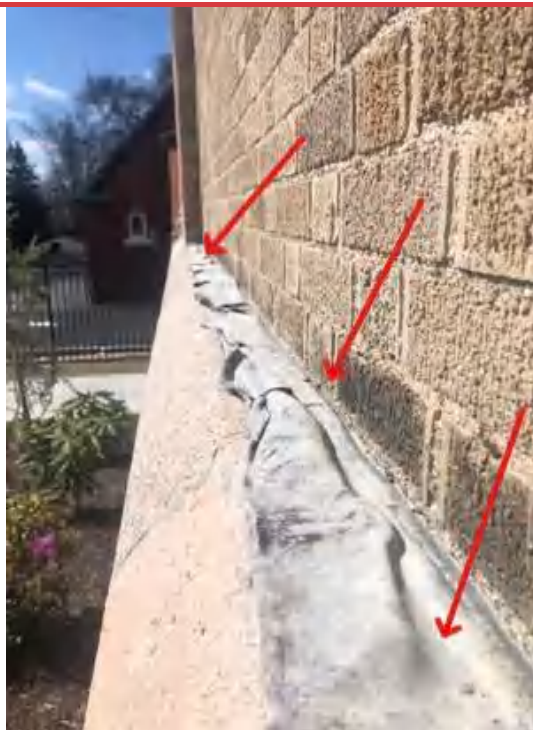
ISSUE 82

The lead flashing on both sides of the front of the building needs attention. Needs to be flattened and sealed.

Baystate

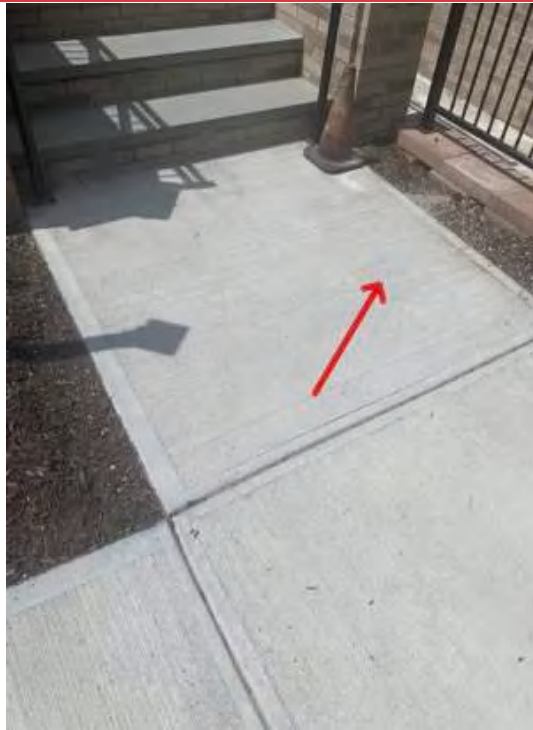
ISSUE 83

Pitches wrong so water pools creating a dangerous condition in winter.
